# Blue River Integrated Water Management Plan

Assessment of Current Aquatic Habitat, Hydrology, and Hydraulic Conditions in the Blue River Downstream of the Dillon Reservoir Dam

July 2022

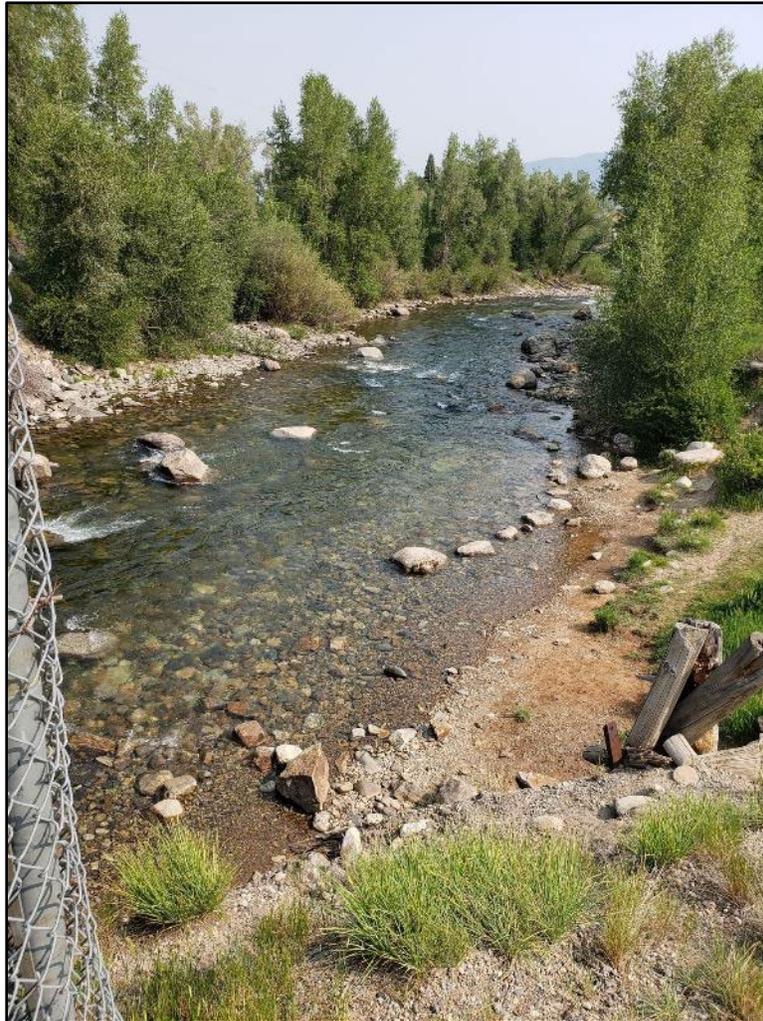
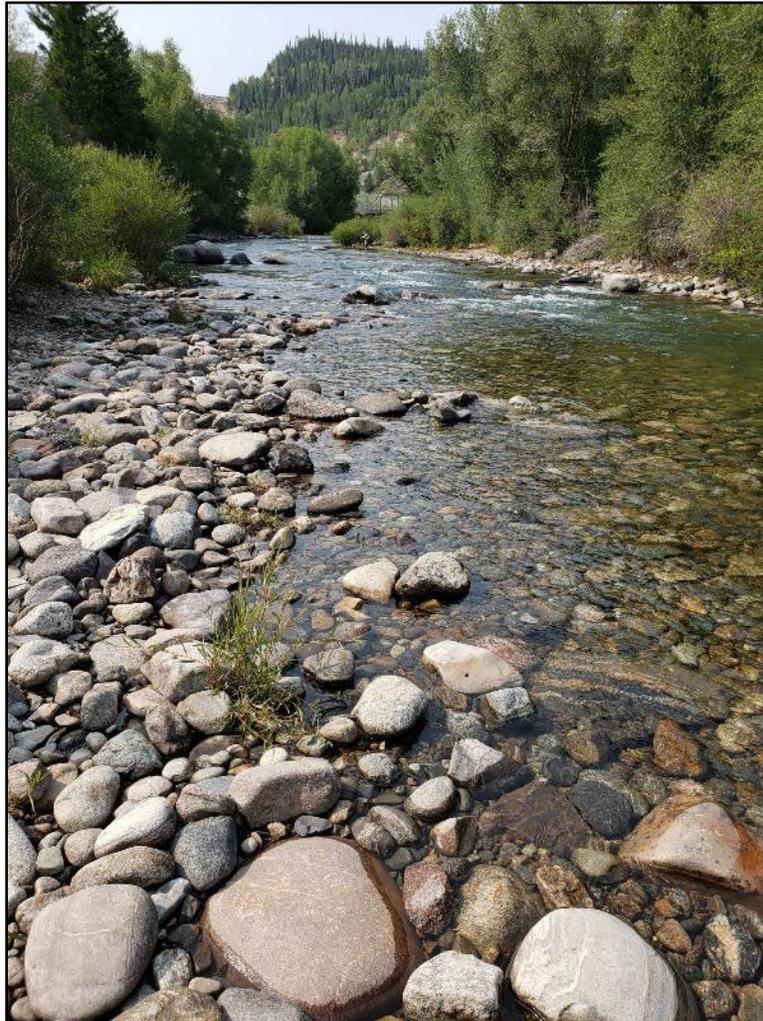
The Blue River at this location is approximately 50 to 55 feet-wide with diverse, naturally appearing habitat features, including pools, runs, and riffles along the meandering channel with vegetated banks (Figure 4). Substrate is primarily cobble and boulder with a near absence of gravel (Figure 5). This location is within a reach Ecological Resource Consultants (ERC) rehabilitated in 2003 through a [Colorado Division of Wildlife] Fishing is Fun grant (Troy Thompson, ERC, personal communication to Bill Miller, April 15, 2022).

Figure 4. July 12, 2021, Blue River reconnaissance Location 1, facing downstream

Figure 5. July 12, 2021, Blue River reconnaissance Location 1, facing upstream

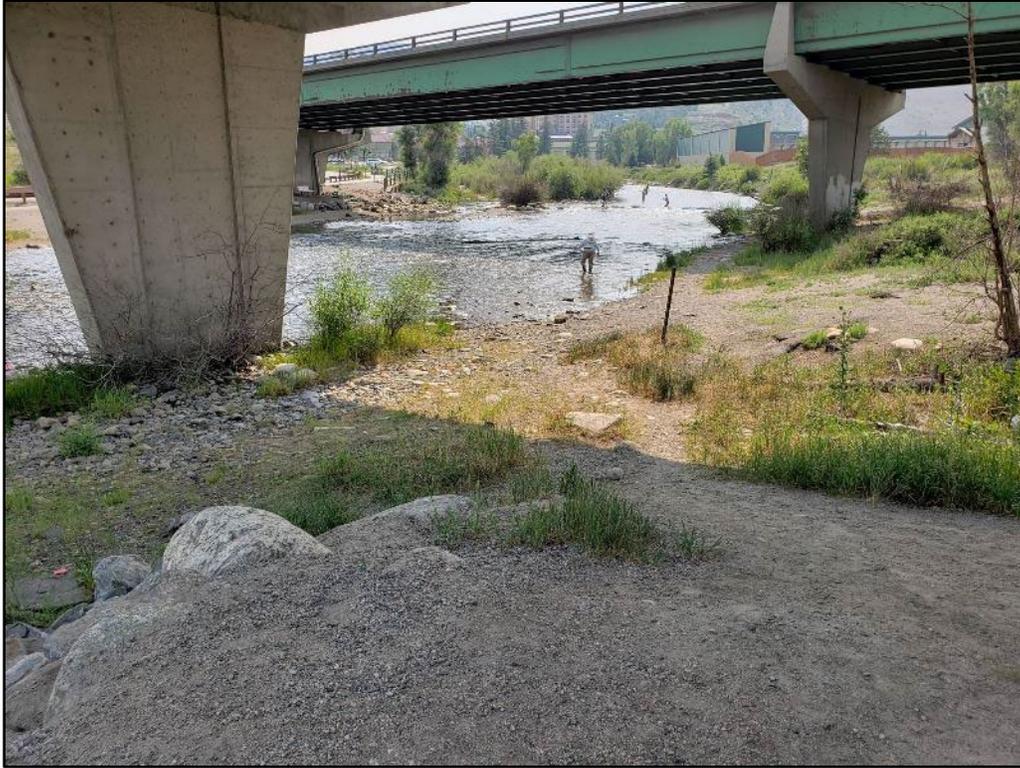
The river at this location is wider than Location 1, approximately 75 feet, likely reflecting the hydraulic response to the configuration of several boulder weir drop structures (Figure 6). Cobbles and boulders dominate the substrate. There is a small island upstream of the I-70 Bridge, but flows were too low to inundate the secondary channel along the right bank (facing downstream). No notches or ramps were observed in the drop structures to facilitate fish passage. Water velocity over the drops was very fast. The combination of the water-surface elevation drop and the fast velocity at these structures is likely a passage impediment to fish moving upstream. There are an estimated 12 drop structures along the river from upstream of I-70 bridge to upstream of the most-upstream pedestrian bridge at Silverthorne’s ‘Town Center’ near Location 3.

Figure 6. July 12, 2021, Blue River reconnaissance Location 2, facing upstream

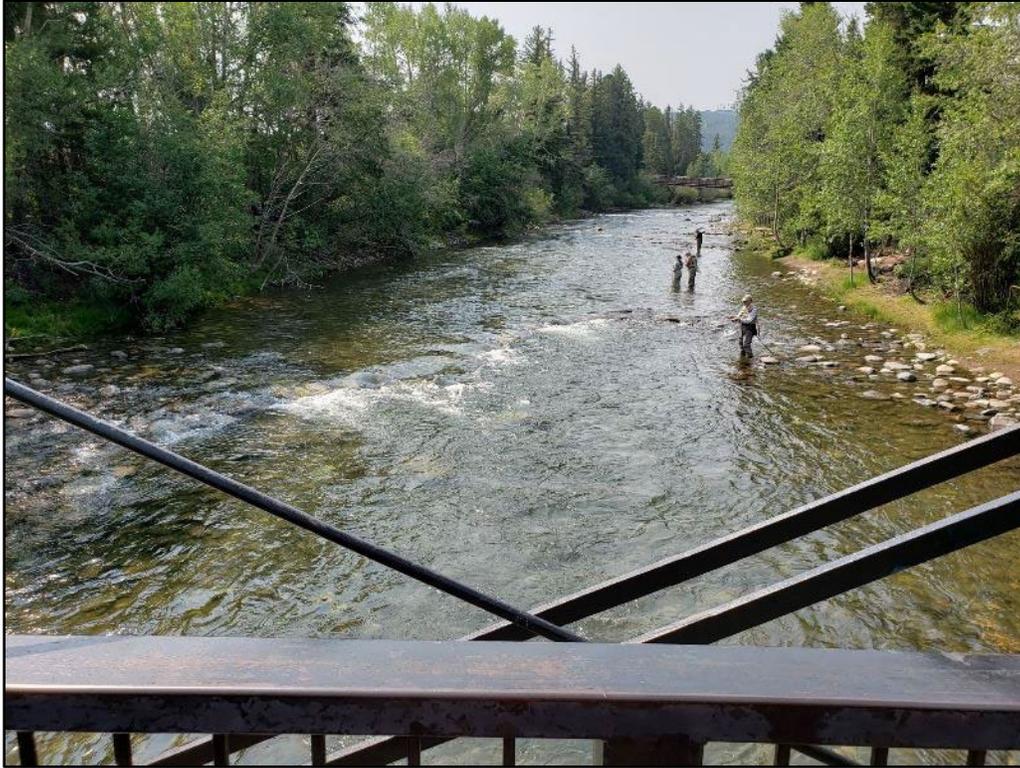
The river in this location has several instream structures that were placed either as partial or complete channel drops (Figure 7). The river width at this location is approximately 80 feet. Substrate is predominately large cobble and boulders. There are numerous boulders downstream of the pedestrian bridge that may have been placed for fish habitat enhancement (Figure 8). A drop structure directly under the pedestrian bridge is placed perpendicular to the river flow and has a drop of approximately 1.5 feet (Figure 9). The structure is constructed of large boulders with very little to no gap between boulders.

Figure 7. July 12, 2021, Blue River reconnaissance Location 3, drop structures

- If the existing boulder weir drop structures are impeding fish passage, modify these structures to allow fish passage and to promote longitudinal channel habitat connectivity. Constructed riffles of configuration like the rehabilitated riffles in Site 1 should be considered as potential templates to replace the drop structures with grade controls that do not impede upstream fish movement.

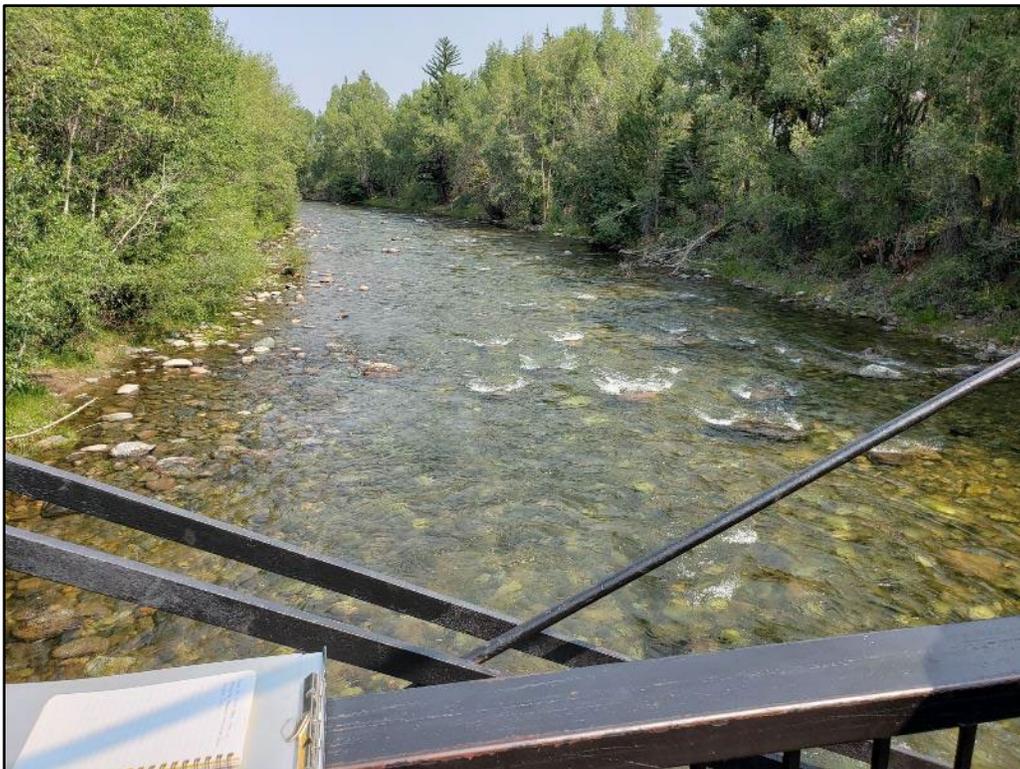
Figure 8. July 12, 2021, Blue River reconnaissance Location 3, possible habitat boulders

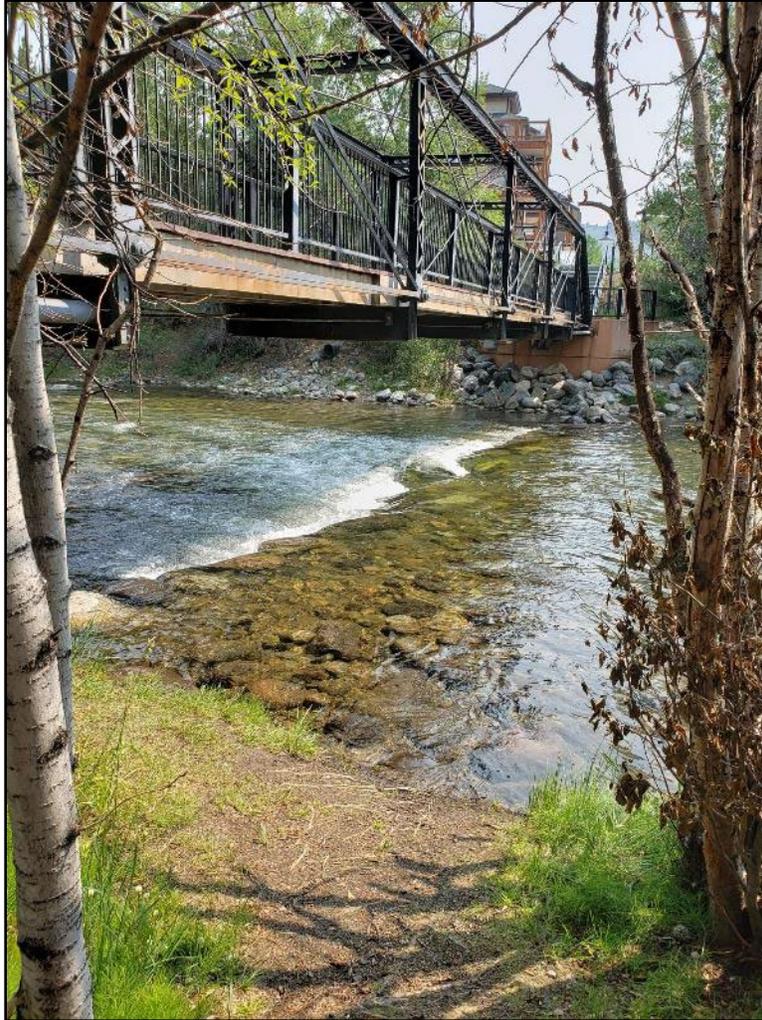
Figure 9. July 12, 2021, Blue River reconnaissance Location 3, drop structure under bridge

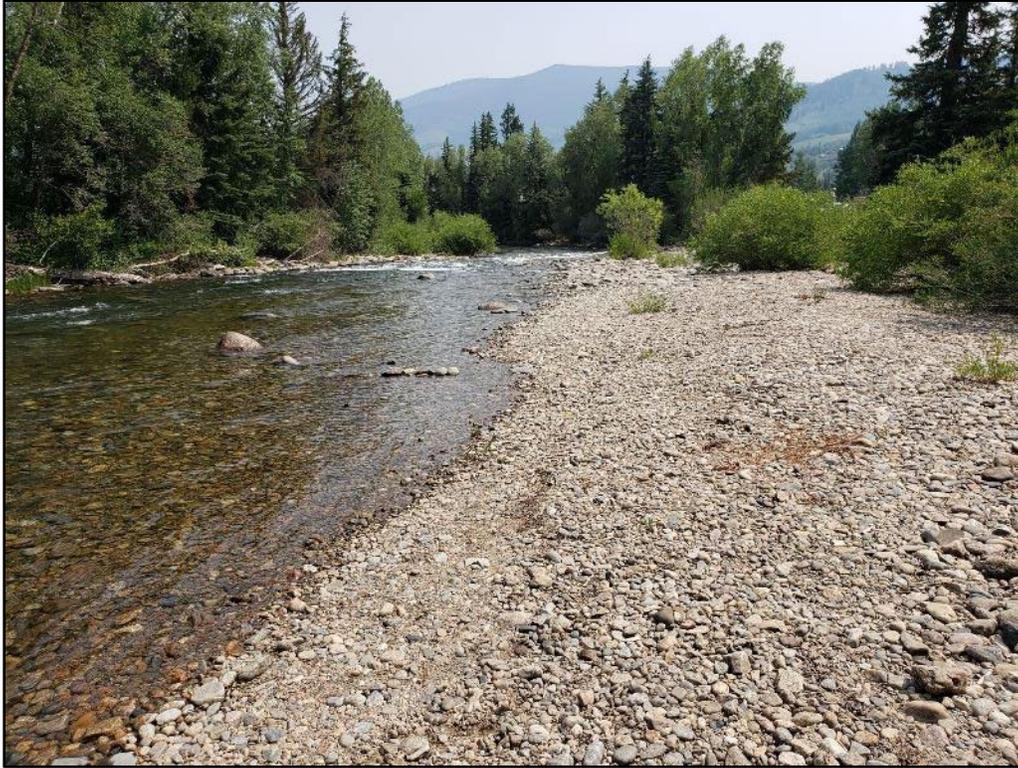
The river at this site is about 50 feet wide, narrower than at locations 3 through 5. The location was accessed from the Silverthorne Town Hall, just downstream from the 6<sup>th</sup> Street culvert crossing. The channel through this location appears to have been modified with a large gravel/cobble bar on river right and a hardened riffle constructed from boulders and cobble (Figure 10). This full channel width riffle does not create a drop like the upstream drop structures; it functions more like a natural riffle and thus does not appear to be a fish passage impediment.

Figure 10. July 12, 2021, Blue River reconnaissance Location 4, gravel bar and hardened riffle

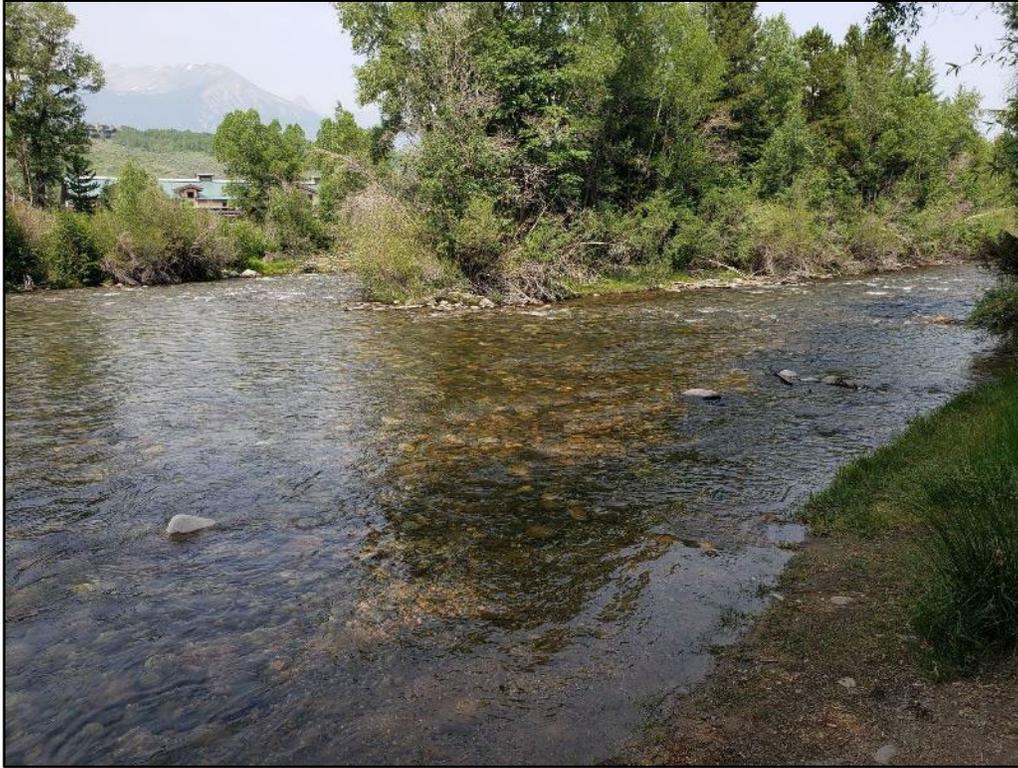
This location was accessed from the Willow Grove Open Space parking area at the north end of Willow Way, with reconnaissance facilitated by walking the Blue River Trail. The river at this location is a wider (about 70 feet), compared to Location 4 and is a single thread channel that splits around a large mid-channel island (Figure 11). The substrate is mostly cobbles with some small patches of gravel. There are some low bank areas that appear to allow connection to the small floodplain during higher flows. The island also has low banks, and it is likely inundated at higher flows.

Figure 11. July 12, 2021, Blue River reconnaissance Location 5, mid-channel island

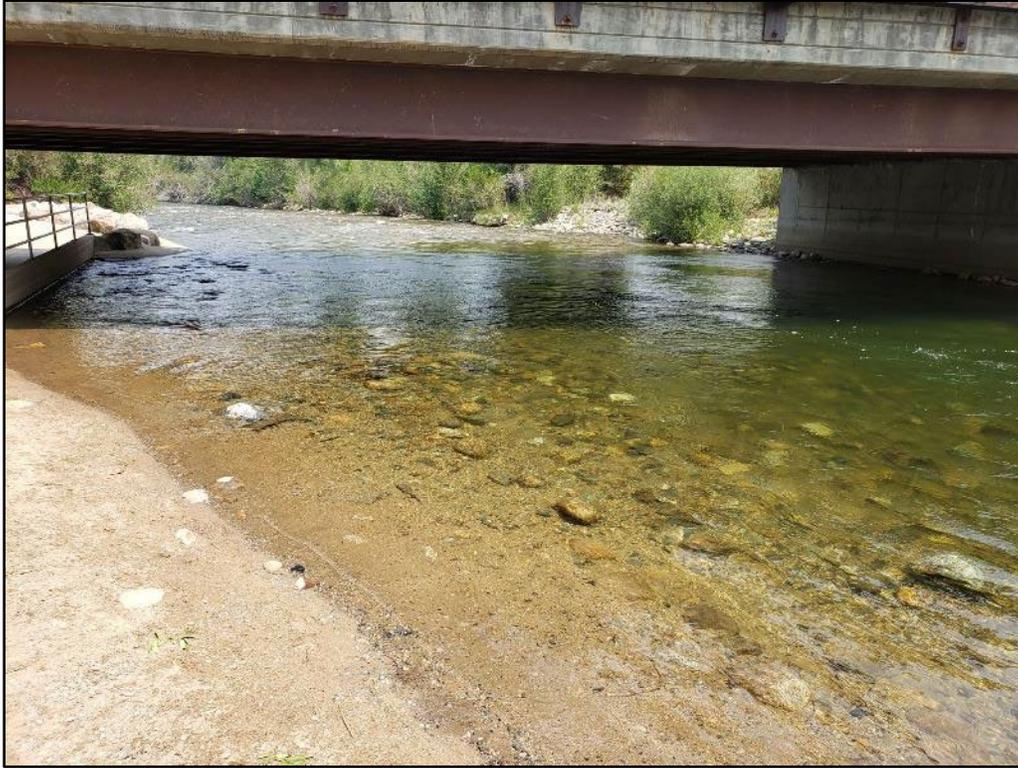
The river at this location, accessed where the Bald Eagle Road Bridge crosses the river, is less urban than the locations upstream. It appears that some channel manipulation has occurred at this location because of the straight channel, perhaps with straightening to accommodate the bridge (Figure 12). The substrate is mostly cobble with some large gravel; although, sand was present in a left bank bar. This is the first notable supply of sand observed downstream of Dillon Reservoir. The source of the sand is unknown; it could be delivered from Willow Creek, which joins the Blue River approximately one-quarter-mile upstream of this location, or it could be from winter sanding operations along Highway 9. Banks are relatively high and steep without much connection to the floodplain downstream of the bridge.

Figure 12. July 12, 2021, Blue River reconnaissance Location 6, sand bar at the Bald Eagle Rd. Bridge

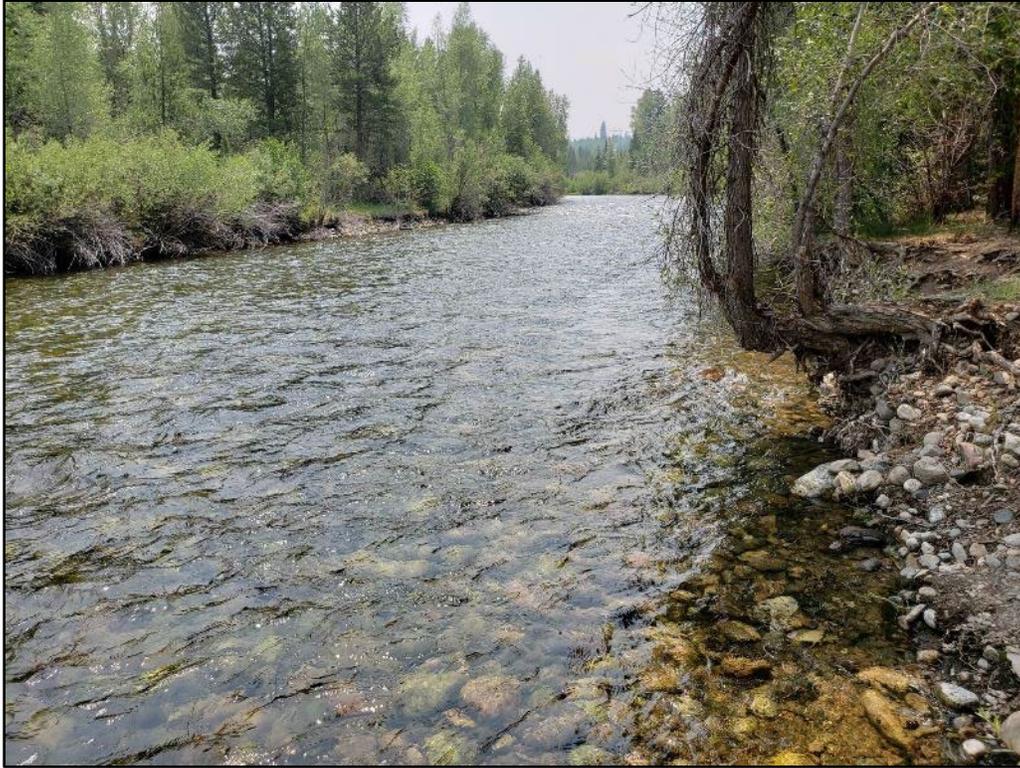
This location was accessed from parking area on the east side of Highway 9 approximately one-quarter mile upstream from the Maryland Creek Park. The river at this location is approximately 65 feet wide. The habitat is primarily riffle and run with cobble-dominated substrate (Figure 13). Banks in this location appear relatively low and well vegetated with little urban encroachment. It is likely the floodplain is hydraulically connected during higher flows.

Figure 13. July 12, 2021, Blue River reconnaissance Location 7, facing upstream at runs and riffles

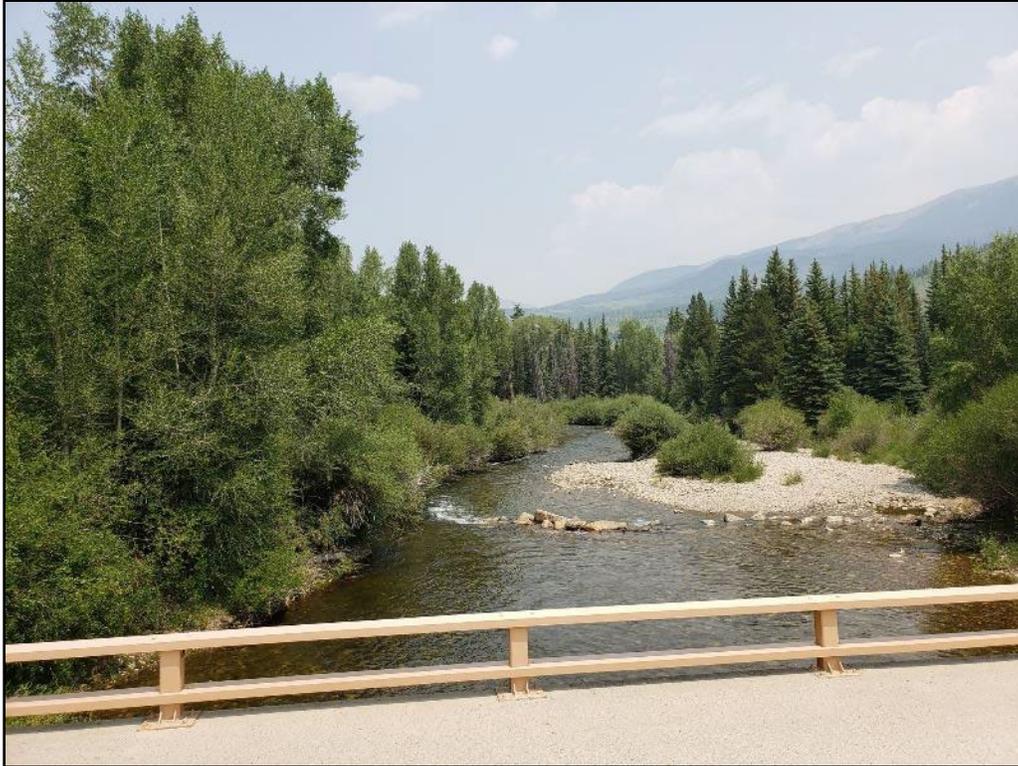
The river at this location is a single channel. The location was accessed from the parking area on the east side of Highway 9 at the turnoff for County Road 1870, which leads to a private bridge for the Rocking A Ranch. There is a cross-channel boulder weir structure installed downstream from the bridge that appears to act as stream barbs or wing dams (Figure 14), perhaps as a habitat feature. Stream substrate is cobble with some gravel. The additional supply of gravel is likely delivered from the Maryland Creek drainage, where the historical depositional fan at the Blue River confluence is upstream of this bridge.

Figure 14. July 12, 2021, Blue River reconnaissance Location 8, facing downstream at weir structure

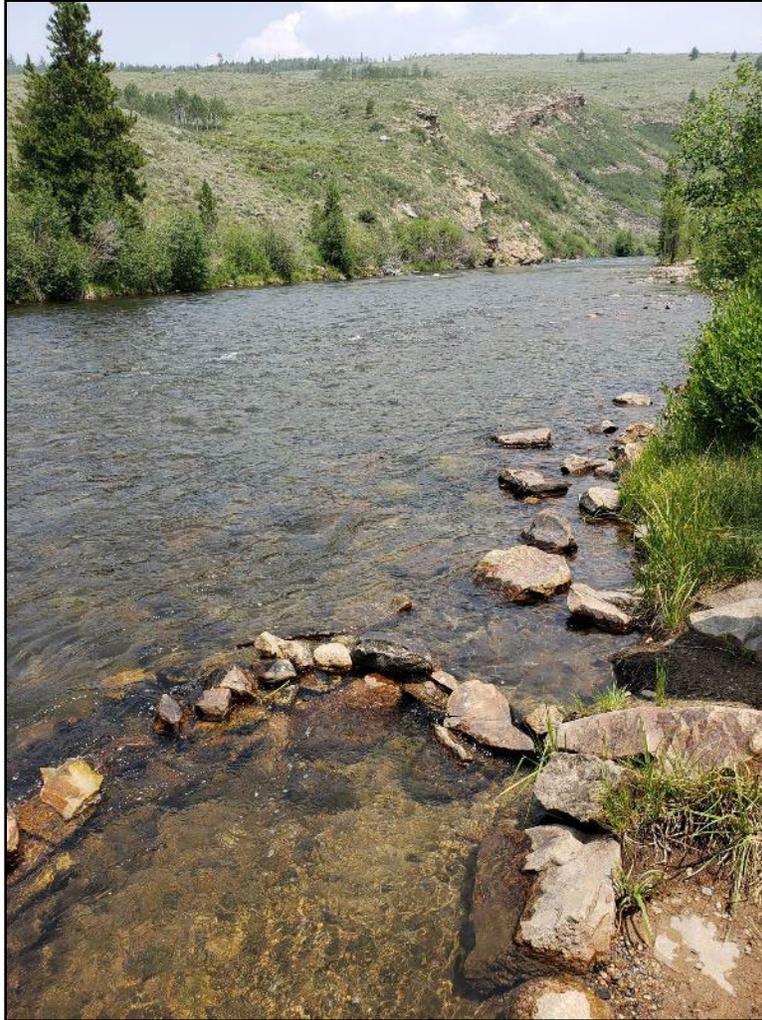
The river at this location has more angular substrate in some locations, likely reflecting direct colluvial input from the adjacent hillslopes. One notable colluvial source is the bedrock outcrop upstream of the campground on the right bank (Figure 15). Downstream from the campground the river substrate is mostly cobble and gravel. The overbank area downstream from the campground has small gravel on the surface and shows evidence of overbank flows. The banks are lower in much of this area and have some lateral connectivity to the river at higher flows (Figure 16).

Figure 15. July 12, 2021, Blue River reconnaissance Location 9, facing upstream at adjacent hillslope

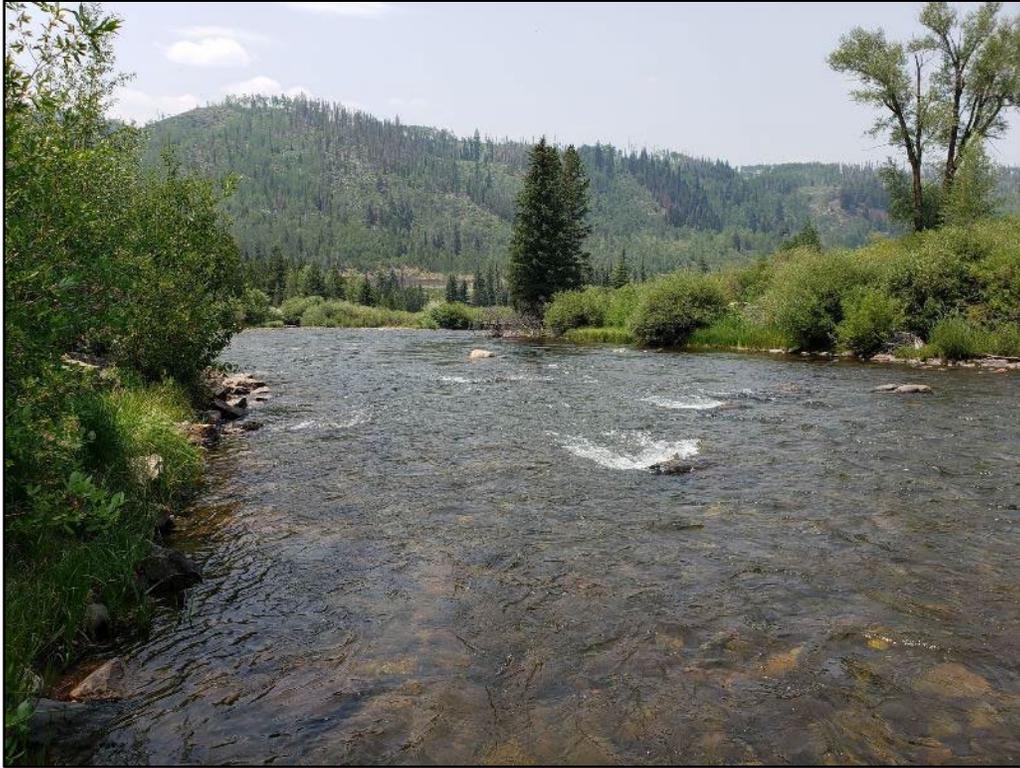
Figure 16. July 12, 2021, Blue River reconnaissance Location 9, facing downstream

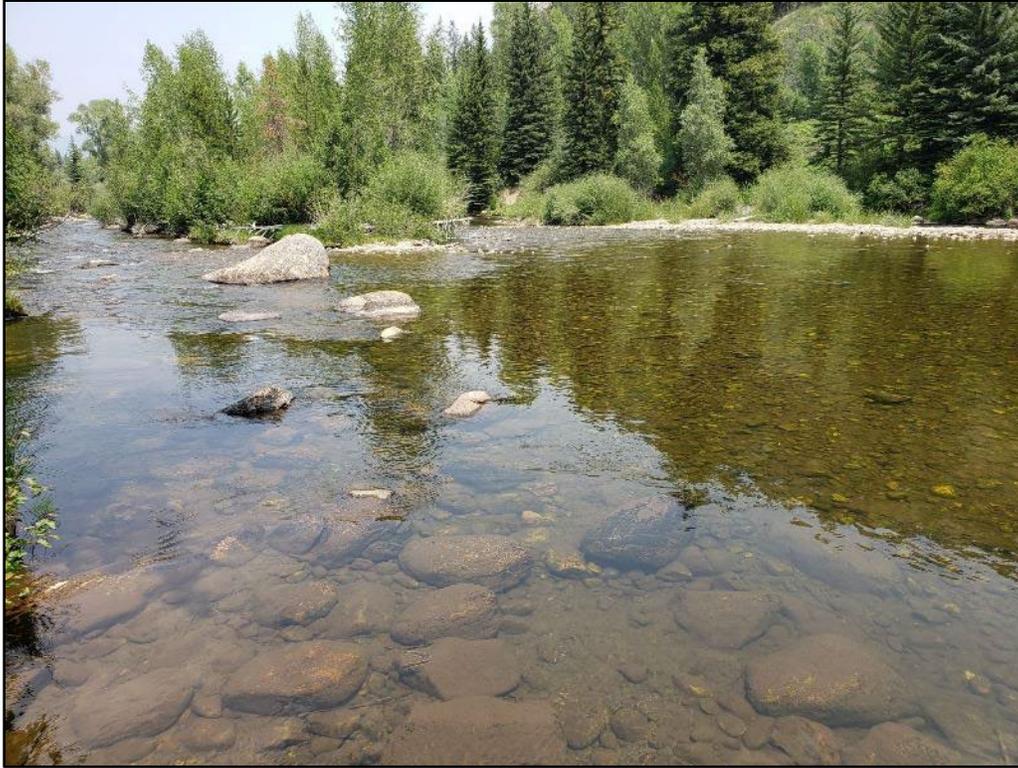
This location was accessed from the parking area along the east side of Highway 9 about 500 feet upstream from the bridge over Boulder Creek. The river at this location has a lower gradient than most of the upper river, perhaps because of the grade control imposed immediately downstream at the confluence of Boulder Creek. Small Age 0 fish were observed at this site but were not identifiable; these fish indicate the presence of a naturally reproducing community. The substrate includes small cobble and various size gravel, and some large wood was noted in the channel (Figure 17).

Figure 17. July 12, 2021, Blue River reconnaissance Location 10, facing downstream
