Blue River Integrated Water Management Plan

Assessment of Current Aquatic Habitat in the Blue River below Dillon Reservoir, Subreach 2.2

July 2023

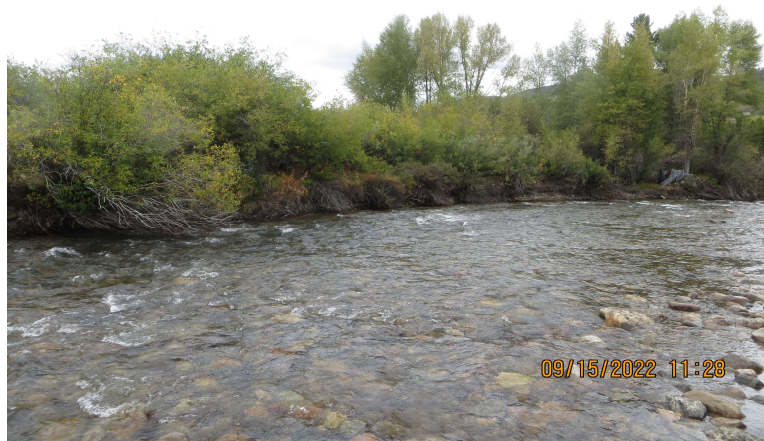
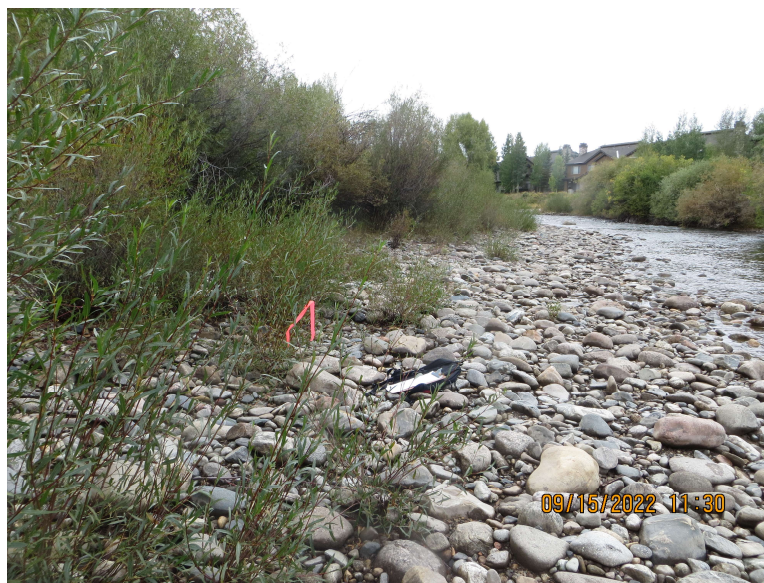
The Blue River at Site 4 is relatively narrow compared to Sites 5 through 8. Habitat features are diverse with pools, glides, and riffles along a single thread channel with cobble bars and willows along the banks and floodplain. This site is located within a residential area. There is a residential development and a pedestrian bike path to the west of the river. A review of the 1954 aerial photo shows this area was primarily a single thread channel with multiple threads and large unvegetated gravel bar deposits in the overbanks. Today there are five existing ponds, three to the west and two to the east of the river. The five ponds were constructed sometime after 1954 and are gravel pits ponds. Based on visual observation, vegetation density is most abundant here compared to the other seven sites.

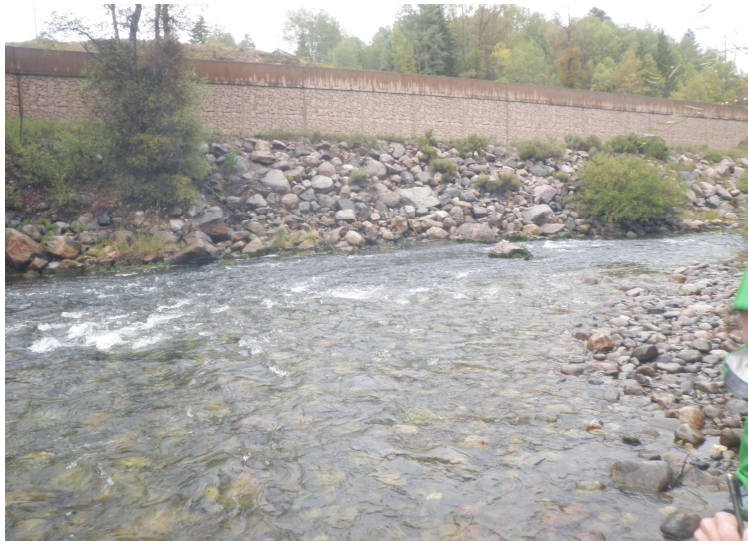
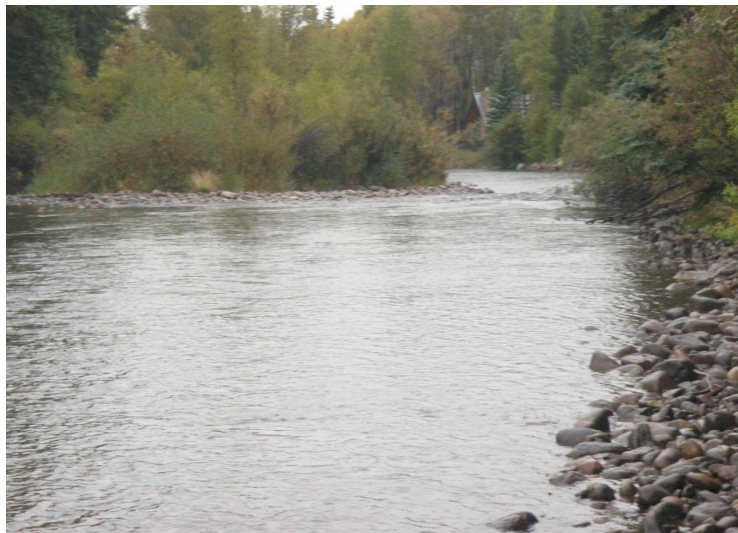
The Blue River at this location is relatively narrow with habitat features, including pools, glides, and riffles along a single thread channel and cobble bars and vegetation along the banks. Encroachments are present including residential development along the east bank, Highway 9 on the west bank, and the Sage Creek Canyon Drive bridge crossing downstream of the study site. Increased sediment is apparent due to runoff from State Highway 9. This site is approximately one-quarter mile downstream from the Blue River Wastewater Treatment Plant and increased nutrients are evident in the form of algae. There are three small ponds located immediately east of this reach, likely remnant gravel pits possibly with hydraulic conductivity to and from this reach of the Blue River. The residents in the subdivision stock the river in this area to maintain fishing quality.

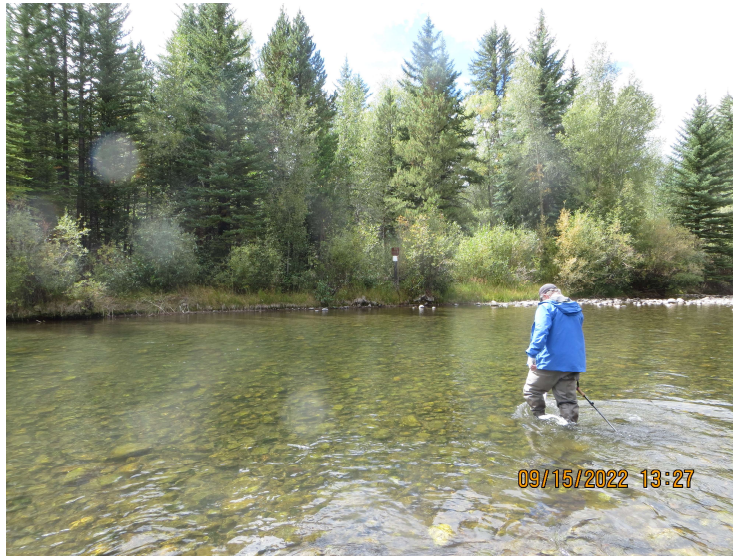
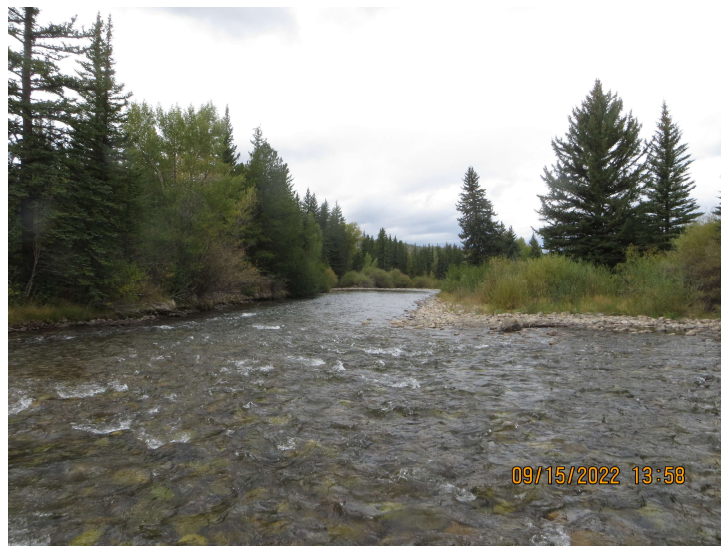
The Blue River at this location is somewhat wider and shallower than the upstream sections but retains habitat features, including pools, glides, and riffles with cobble bars and vegetation along the banks. Portions of the left overbank are used for agricultural production and remnant oxbows can be seen in the fields in the 2019 Google Earth imagery. There are four gravel pit ponds located west of this reach of the Blue River, two west of State Highway 9, and two between the highway and the river. These ponds are not visible on 1985 aerial imagery so they would have been mined over the last 40 years and restored in compliance with state regulations requiring pond liners. Thus, these gravel pits may lack subsurface hydraulic connectivity with the river.

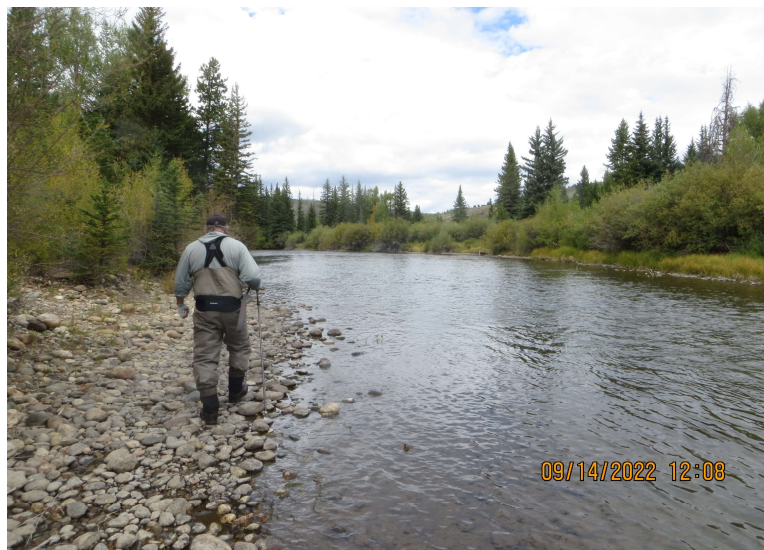
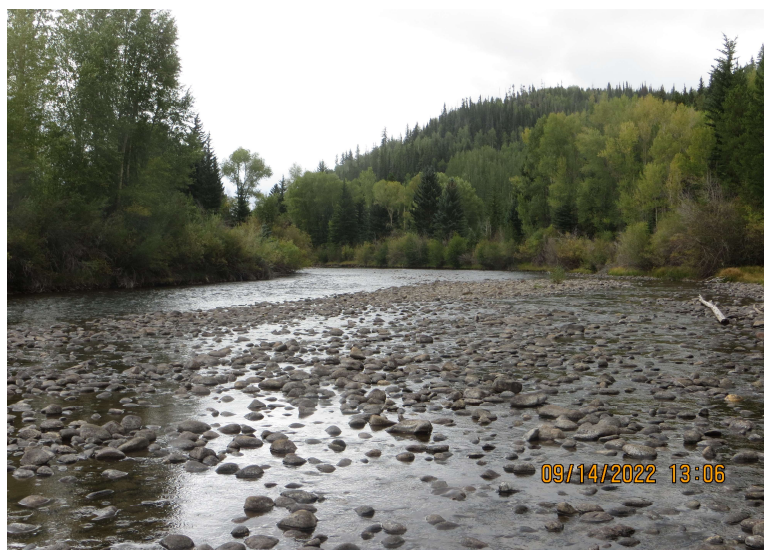
This site is on lands managed by the CPW and the USFS including a popular pedestrian access off State Highway 9 near mile marker 109. The channel is wide when compared to the upstream sites and channel bar formation is less evident compared to the upstream reaches at low flows. The left overbank and the left channel banks show evidence of gravel and boulder deposits or mounds, lack of organic material, and little vegetation except for newly recruited lodgepole pine. Some of these deposits appear similar to the deposits created by gravel mining, however, further review indicates that this area may have been exposed at one time to a debris or avalanche event from the west drainage, resulting in these gravel deposits and possibly contributing to the overly wide channel.

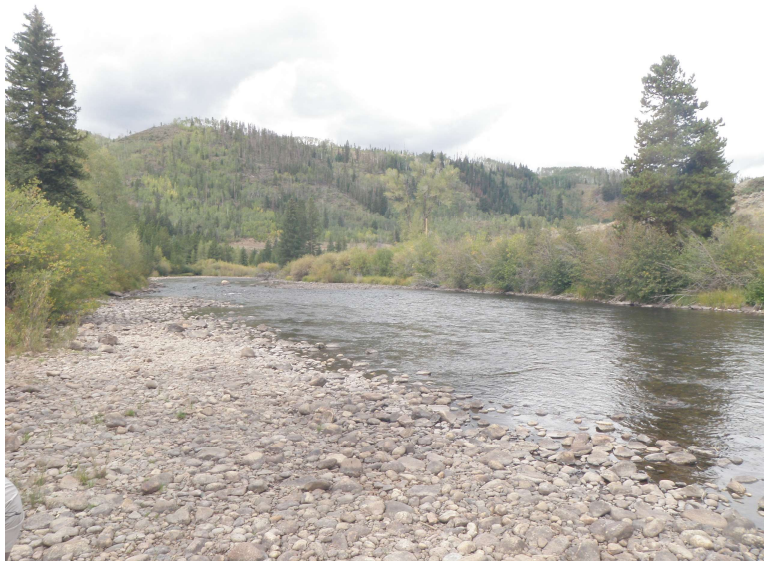
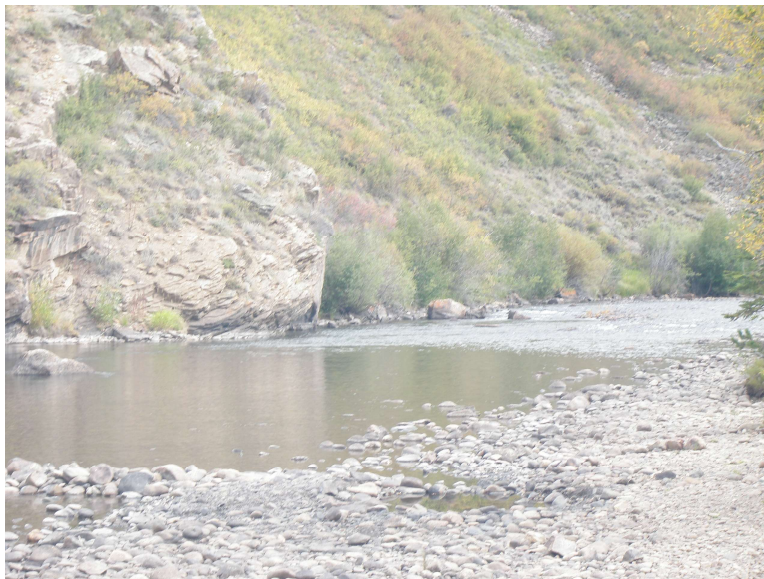
This site is located within USFS-managed lands including the Blue River Campground. The river at this site is moderately wide but does have one deep pool formation. Campground use and pedestrian traffic to and from the river have impacted the left channel banks and left overbanks. The upstream right channel bank is largely comprised of bedrock outcrop. The deep pool formation is located along this upstream bedrock outcrop. Further downstream the right bank transitions to a wetlands bar and the channel widens. Channel bar formation is less evident than the upstream reaches at low flows.

3. Identify damaged channel banks at popular river access points where the loss of vegetation and erosion have occurred on some of the steeper banks due to overly steep banks and frequent foot traffic. This is prevalent at Sites 1, 2, and 8. These areas should be revegetated and restabilized along the banks, with improved or delineated pedestrian access to the river.

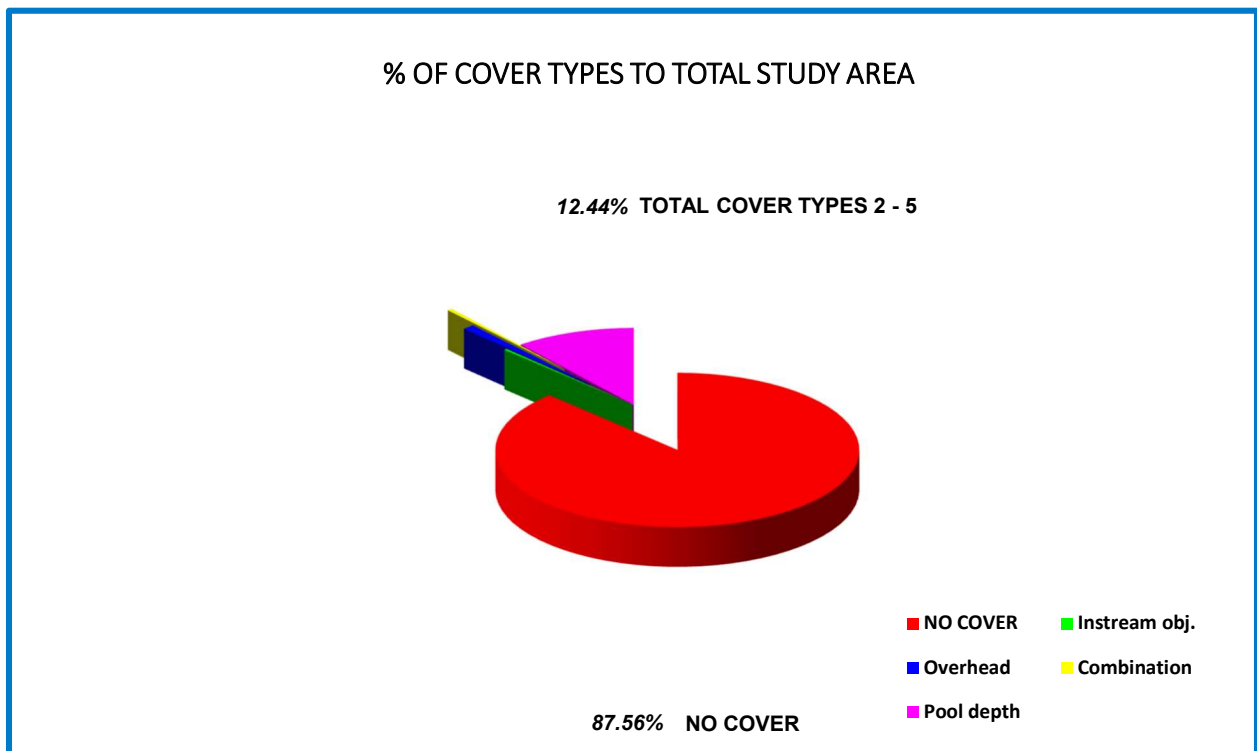
Figure 22. Habitat assessment Subreach 2.2 Site 8, USFS Campground, percent cover by cover type.

Glides (46.5%) and riffles (39.4%) comprise most of the habitat features at this site. Glide depths are shallow, and similar in depth to riffle sections, thus providing little to no cover (Table 5, Figure 22). One large pool associated with a bedrock outcrop on the right bank provides the only cover observed at this site with a residual pool depth deeper than in the upstream pools. The pool has several medium to large boulders that provide combination cover in the pool habitat. Overall, the cover component remained lower than in upstream narrower channels, however, some boulders in the glides would provide additional cover at higher flows. Spawning-sized gravels are available in small areas of the glide and riffle habitat.
