## Blue River Integrated Water Management Plan

# Blue River Conceptual Restoration Master Plan Dillon to USFS Campground

July 2023

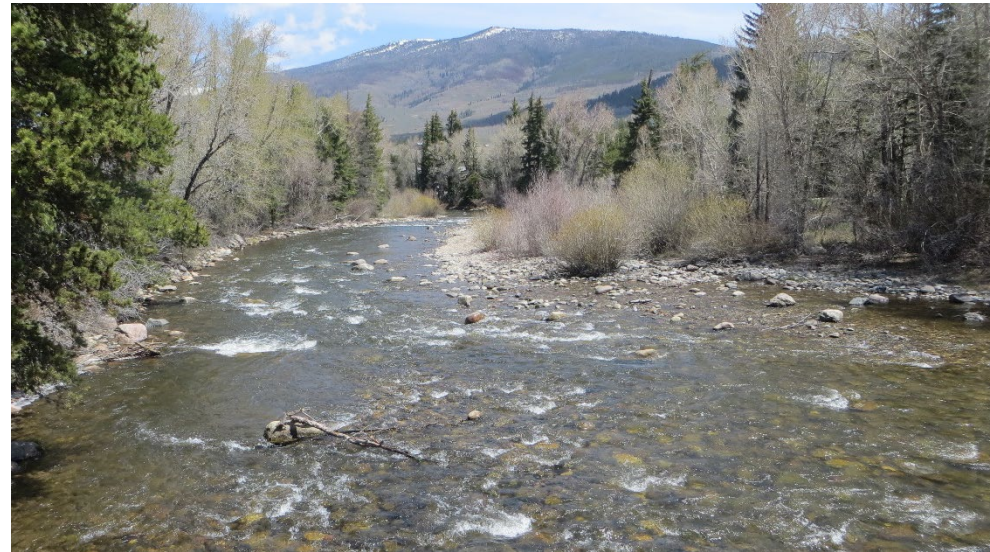
**Figure 8. Photo of Point Bar, Pool, and Riffle downstream of 6<sup>th</sup> Street.**

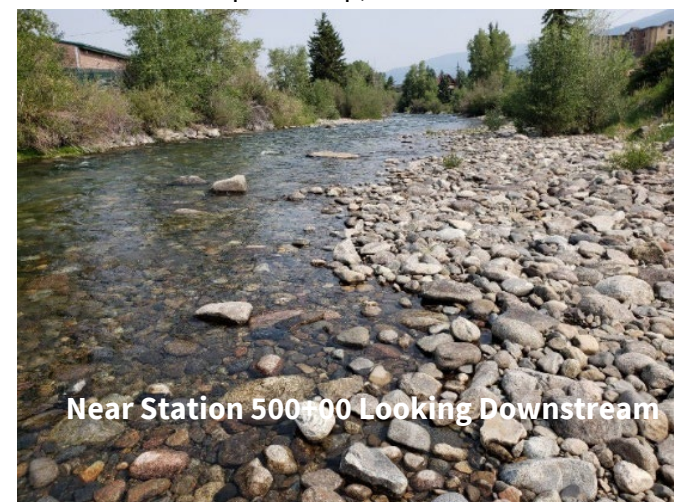
Near Station 500+00 Looking Downstream

This section of the Blue River is characterized by Study Site 1 which was rehabilitated by the Town of Silverthorne in 2003. The habitat analysis conducted in 2021 indicates the hydraulic habitat parameters, primarily wetted perimeter, and depth, meet, or exceed the minimum standards set by instream flow standards likely the result of the 2003 restoration efforts. Within the low flow channel, this Subreach has natural appearing habitat features, including pools, runs, and riffles along a meandering channel and a narrow band of vegetation lining the banks. This reach could be used as a reference for future restoration of other sections of the Blue River. The residual pool depth (pool depth that would be present at 'zero' flow) was measured at 2.4 feet. The area for glides and riffles was almost equal at approximately 46 percent of the total area, with pool habitat making up the remaining 7 percent. The substrate is primarily cobble and boulders with a near absence of spawning-size gravel. Channel banks in this are quite steep, and some sections have eroded due to foot traffic accessing the river.

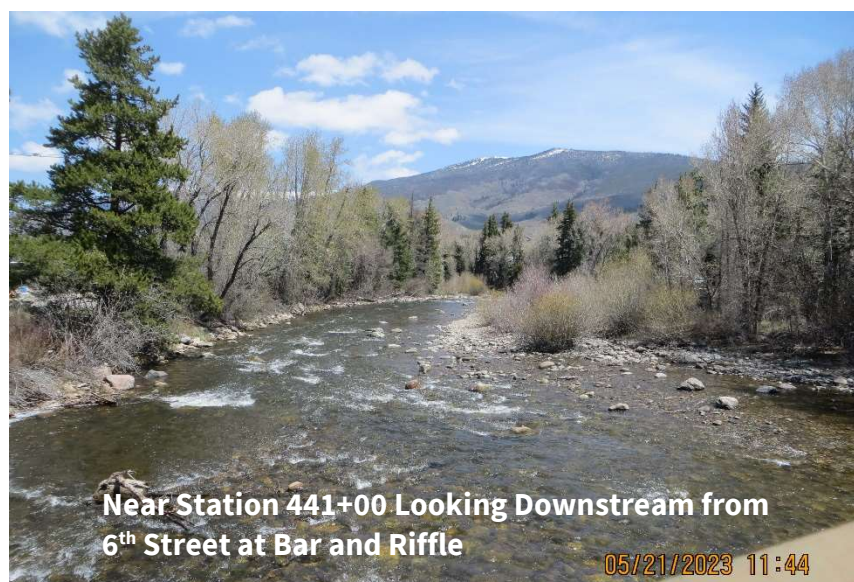
Near station 435+50 adjacent to the Town of Silverthorne library, immediately downstream of 6<sup>th</sup> Street a cobble bar and riffle formed, or may have been constructed, and for a short length the low flow channel displays natural appearing habitat features. This section could be used as a reference section to inform on developing other cobble bars and riffles along this reach.

1. Narrow channel using point bars. Enhance and construct riffle habitat.
2. Construct pools of sufficient depth on the outer banks.
3. Remove the existing drop structures. Construct riffles as required to maintain channel slope.
4. Revegetate and stabilize damaged channel banks.
5. Construct trails to direct foot traffic to the river. Use gravel to stabilize the trail surface and minimize erosion. Include steps along the steeper bank sections, particularly near the Silverthorne Town Pavilion.

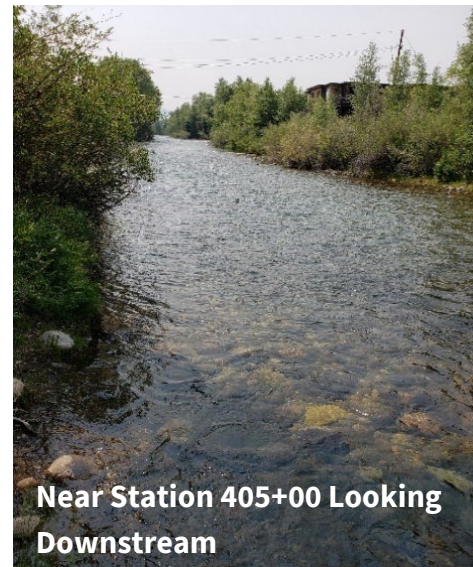
Near Station 405+00 Looking Downstream

The Blue River Trail bridge bisects a 1,500-foot-long island that splits the main channel into two side channels. These side channels appear to evenly split flows and nearly double the width of the single channel mainstem above and below the split. As a result, flows in both side channels appear to be quite shallow. There is one drop structure located along the east side channel. Increased depths and improved hydraulic conditions at low flows could potentially be achieved by confining low flows to one of the splits.

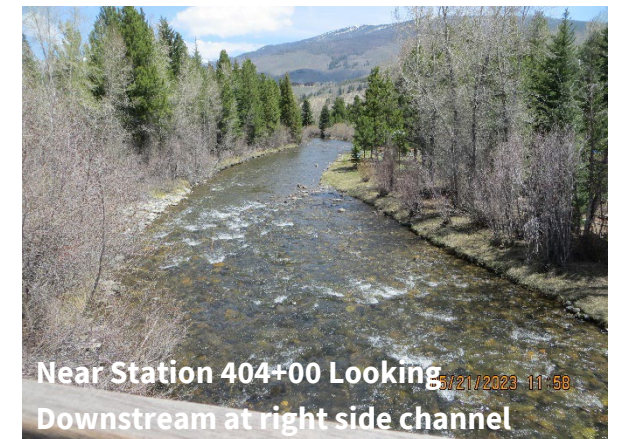
Near Station 404+00 Looking Downstream at right side channel

- The channel is transitioning to characteristics of Study Site 4 where the FACStream analysis indicates a ‘mild/significant degree of impairment’ due to low rankings for flow and biotic structure and higher-ranking variables for floodplain and stability. The habitat analysis at Study Site 4 indicates this site has some of the higher percentage of cover habitat compared to other sections.

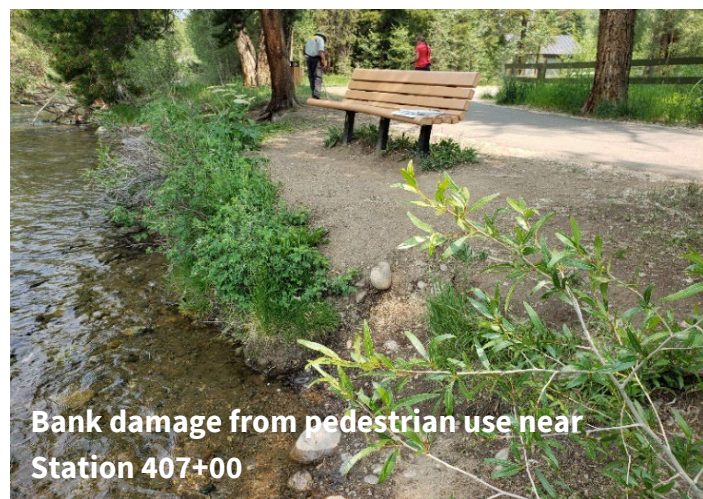
Bank damage from pedestrian use near Station 407+00

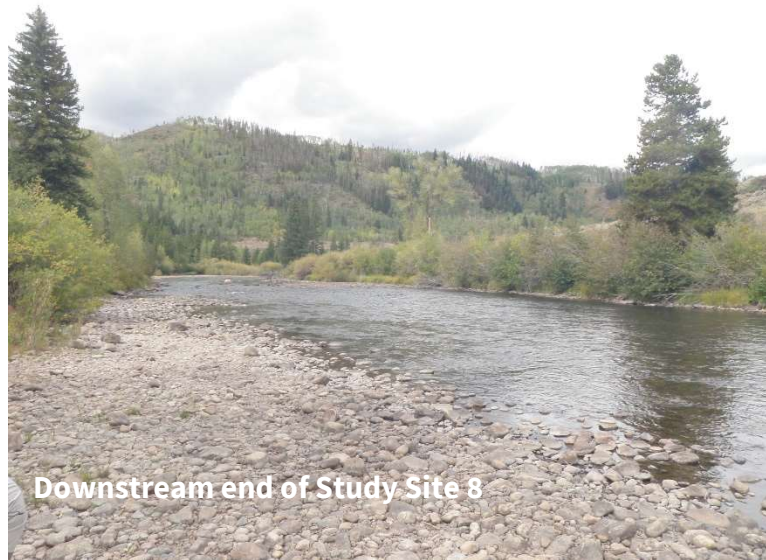
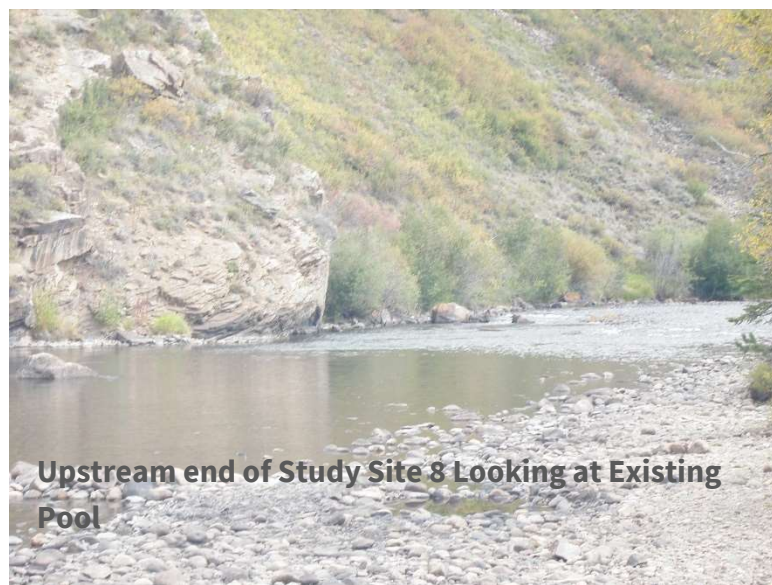
Study Site 8 is located in this reach. Glides (46.5 percent) and riffles (39.4 percent) dominate the habitat features. Glides are shallow and provide little cover. One large pool is present, associated with a bedrock outcrop on the right bank. This pool provides the only cover observed at this site although the residual pool depth is much better than

in the upstream pools. The one large pool has several medium to large boulders providing both in-stream and boulder cover pool habitat. Overall, the cover component is lower than in upstream narrower channels, however, boulders in the glides could provide additional cover at higher flows. Spawning-sized gravels are available in small areas of the glide and riffle habitat.
