# Blue River Integrated Water Management Plan

Assessment of Current Aquatic Habitat, Hydrology, and Hydraulic Conditions in the Blue River Downstream of the Dillon Reservoir Dam

July 2022

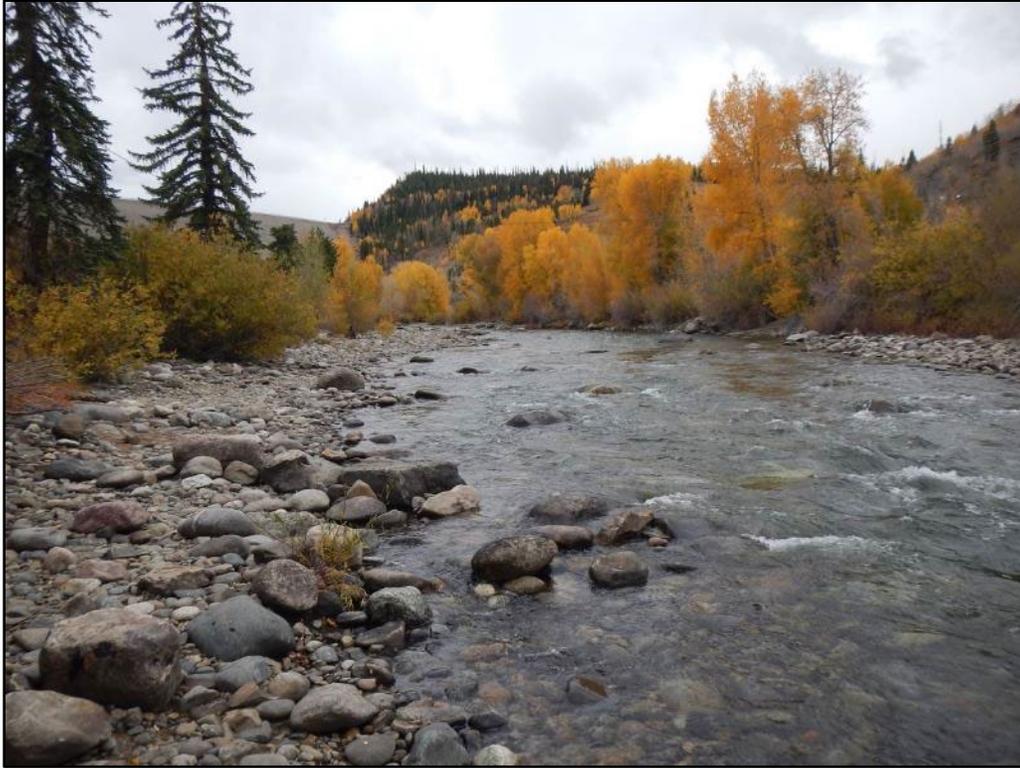
Figure 28. Habitat assessment Site 1 facing upstream during habitat inventory

The habitat inventory shows that the upstream reach at Site 1 is the narrowest, most naturally appearing channel, with hydraulic conditions during low flows most conducive to appropriate aquatic habitat for all aquatic species including trout. Site 1 has several deep pools for refuge habitat at low flows. Site 1 also does not have any impediments to fish movement. Site 2 is the widest of the three sites, especially for glide habitat. The stream width is controlled by the full channel width drop structures. These structures provide grade control, which reduces flow depth upstream of the structure and present impediments to upstream fish movement. The existing partial channel width, offset grade control structures function to control stream gradient and allow unimpeded fish movement. The impeded fish movement, especially by small trout and

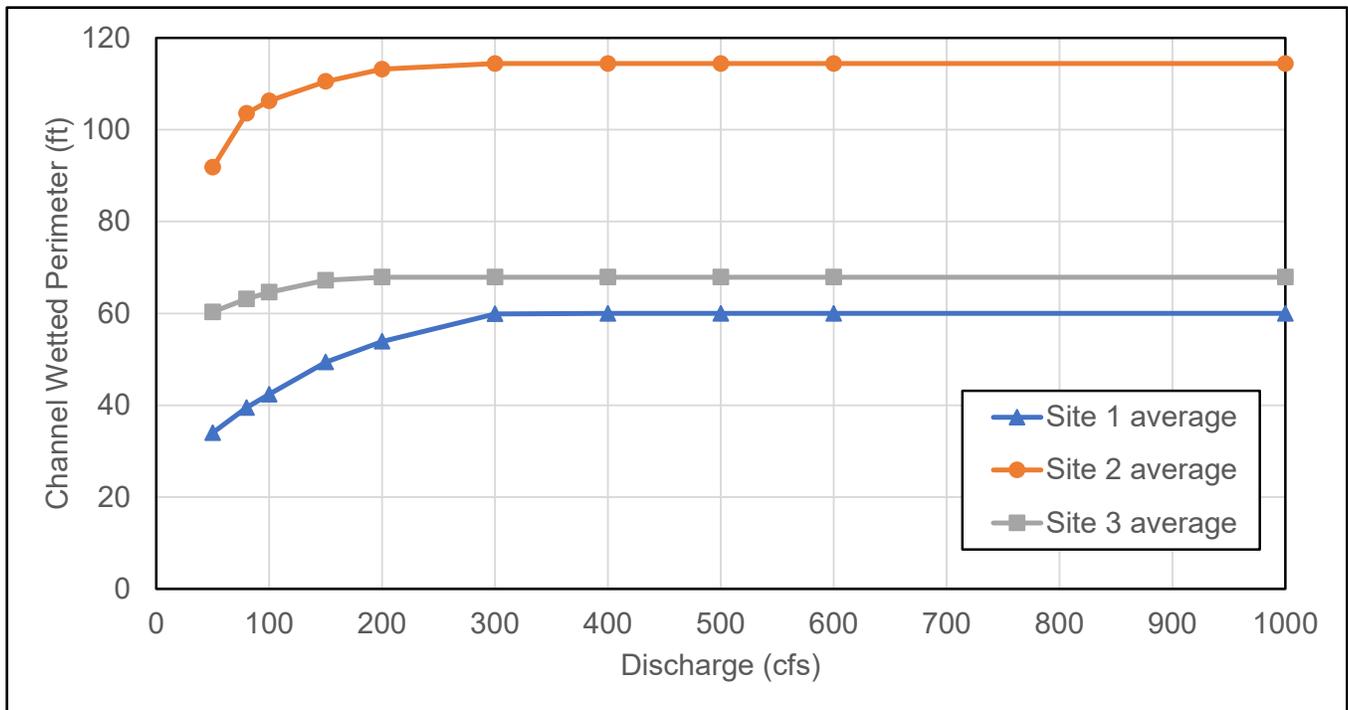
Figure 37. Pool habitat type rating curve for channel wetted perimeter

Wetted perimeter is narrowest for pools in Site 1 and widest for Site 2 (Figure 37). Shorter wetted perimeters for a given flow are associated with more efficient channel morphology for conveying water and sediment, meaning narrower and deeper channels. Wetted perimeter is relatively constant over the range of flows simulated for Site 2 and Site 3, because wider channels produce lower depth changes for incremental changes in flow relative to narrower channels. Pools in Site 1 were associated with alternate bars, likely reflecting the 2003 rehabilitation design. As the flow increases, the wetted perimeter at Site 1 pools increases steadily until it reaches the channel capacity at approximately 300 cfs.

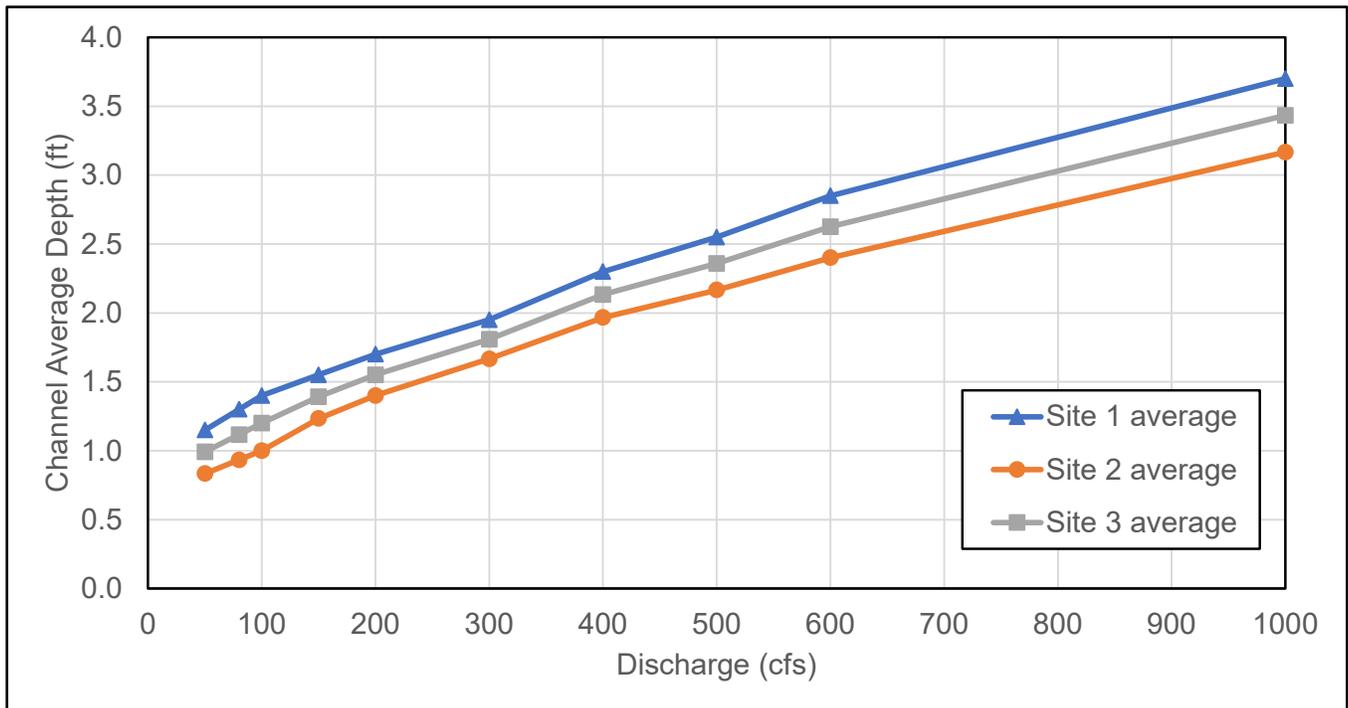
Figure 38. Pool habitat type rating curve for channel average (hydraulic) depth

Average (hydraulic) depth of pools over the range of simulated flows is greatest for Site 1 and lowest for Site 2 (Figure 38). Average depth for Site 1 ranged from 1.2 feet at 50 cfs to 3.7 feet at 1000 cfs (Table 6). Average depth for Site 2 was lowest and ranged from 0.8 feet to 3.2 feet. Average depth of pools in Site 3 ranged from 1.0 foot at 50 cfs to 3.4 feet at 1000 cfs.

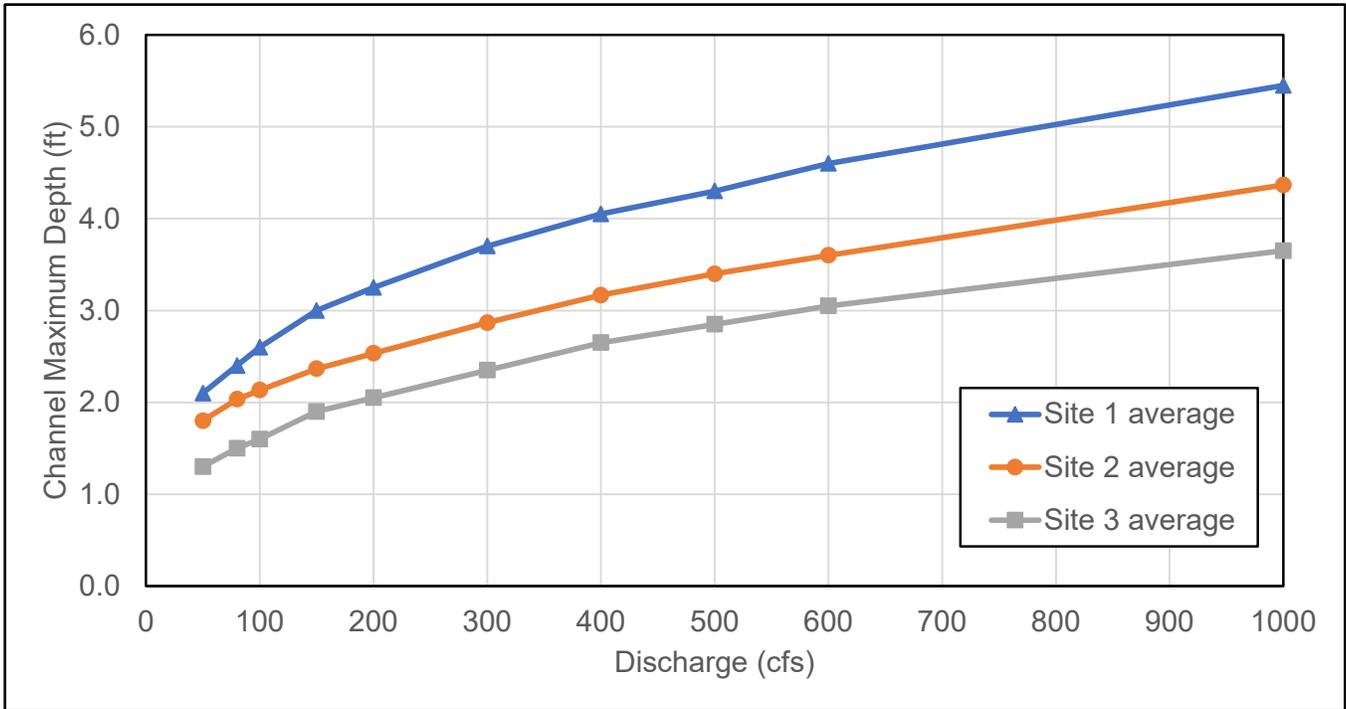
Figure 39. Pool habitat type rating curve for channel maximum depth

Site 1 had the greatest maximum pool depths of the three sites. Maximum depth at Site 1 ranged from 2.1 feet at 50 cfs to 5.5 feet at 1000 cfs (Figure 39). Maximum depth at Site 2 ranged from 1.8 feet to 4.4 feet. Maximum depth for Site 3 ranged from 1.3 feet at 50 cfs to 3.7 feet at 1000 cfs.

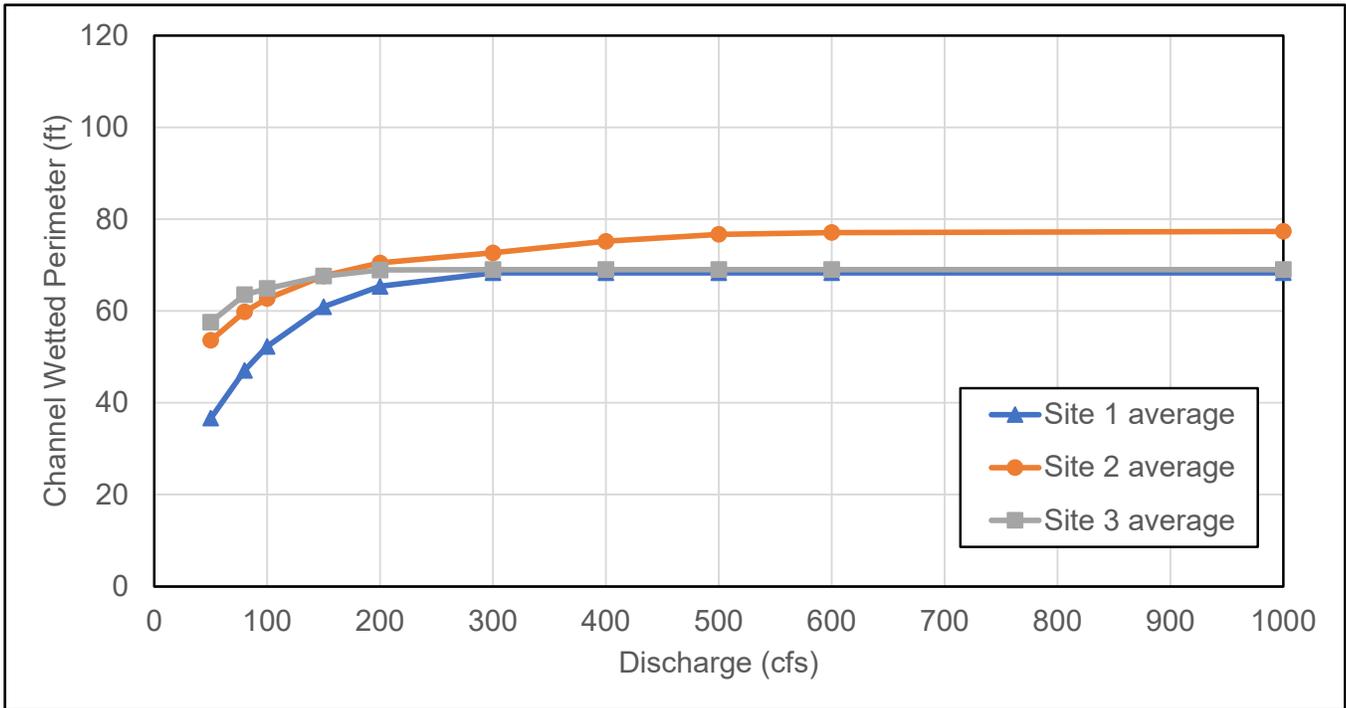
Figure 40. Riffle habitat type rating curve for channel wetted perimeter

Riffle wetted perimeter was narrowest at Site 1 and widest at Site 2 (Figure 40). Wetted perimeter at Site 1 ranges from 36.6 feet at 50 cfs to 68.3 feet at 1000 cfs (Table 7). Wetted perimeter at Site 2 ranges from 53.6 feet at 50 cfs to 77.3 feet at 1000 cfs. Wetted perimeter at Site 3 ranges from 57.6 feet to 69.0 feet. Bank to bank wetted perimeter in the channel is reached at 300 cfs, for Sites 1 and 3 whereas bank to bank wetted perimeter continues to increase to 1000 cfs at Site 2. This is because the narrower and deeper channel through Sites 1 and 3 reaches capacity around 300 cfs, but the shallower and wider channel through Site 2 does not. However, all sites have more than 50 percent of the bank-to-bank wetted perimeter even at a flow of 50 cfs.

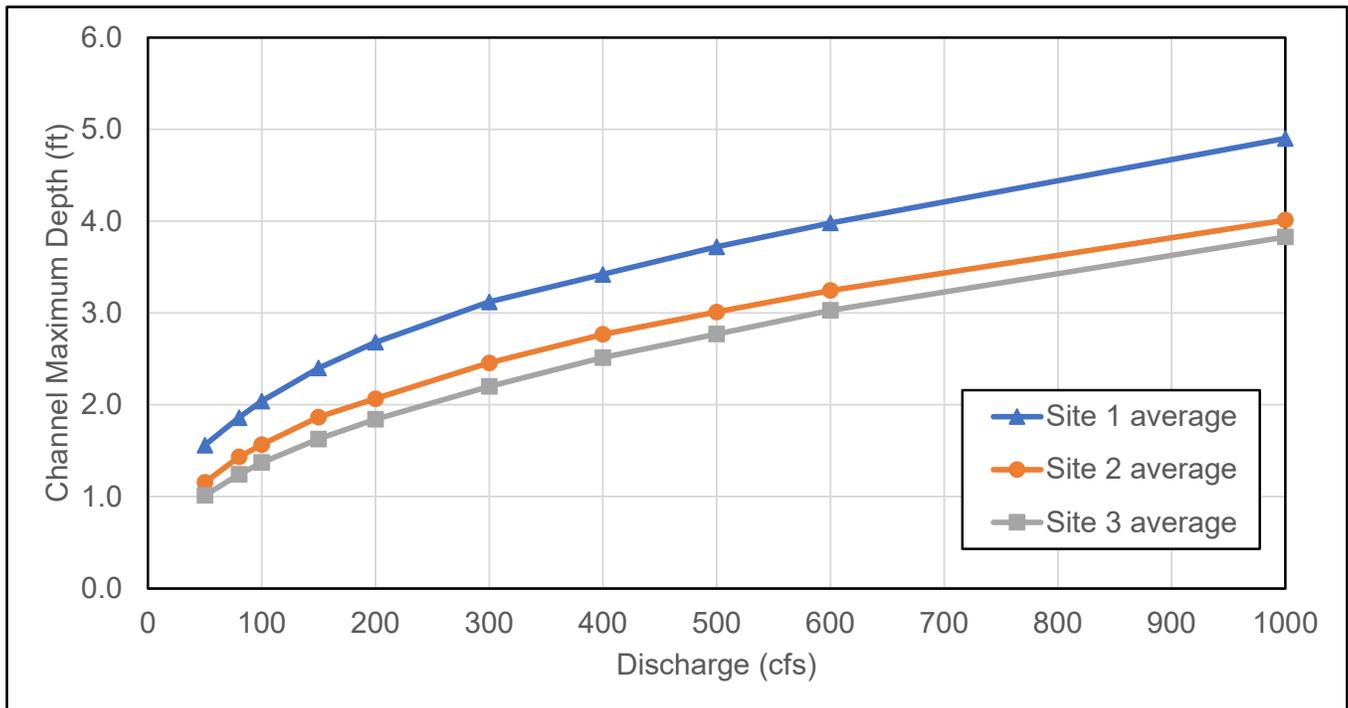
Figure 42. Riffle habitat type rating curve for channel maximum depth

Maximum riffle depth is greatest at Site 1 and lowest at Site 3 (Figure 42). Maximum riffle depth at Site 1 ranges from 1.6 feet to 4.9 feet. Maximum riffle depth at Site 2 ranges from 1.2 feet to 4.0 feet. Maximum riffle depth at Site 3 ranges from 1.0 foot to 3.8 feet.

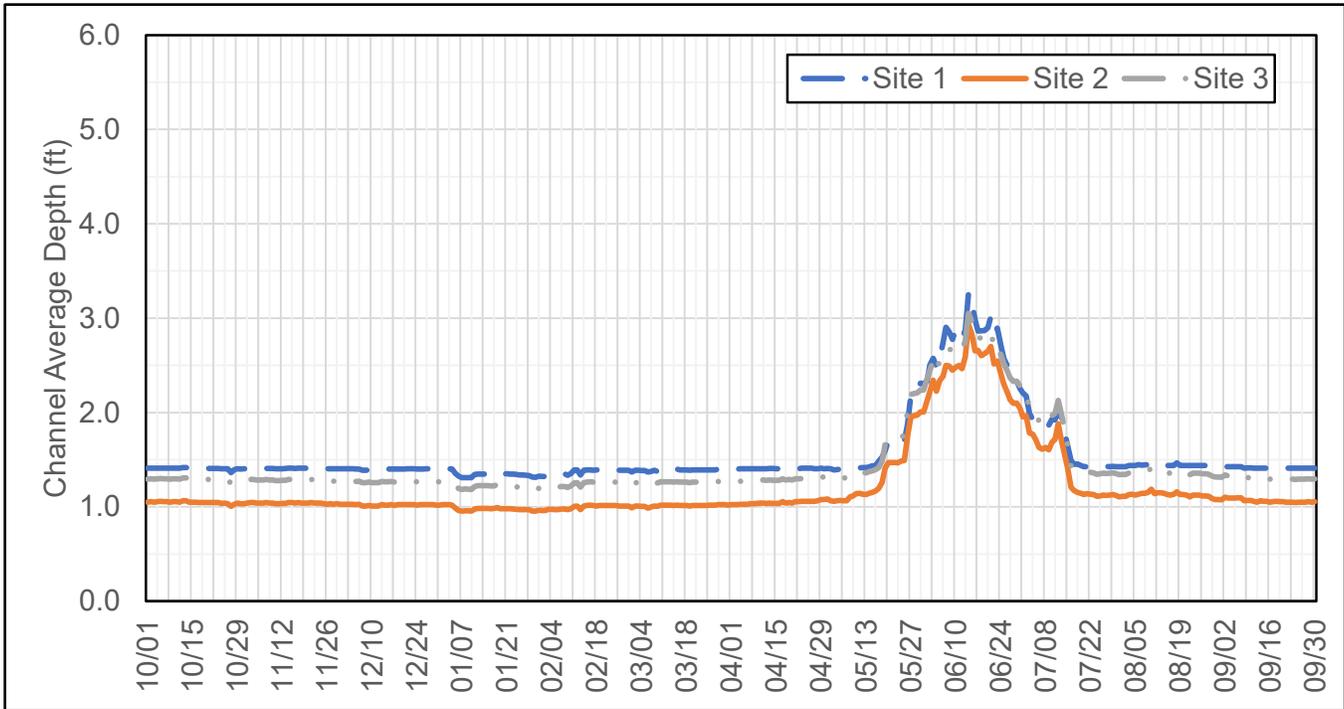
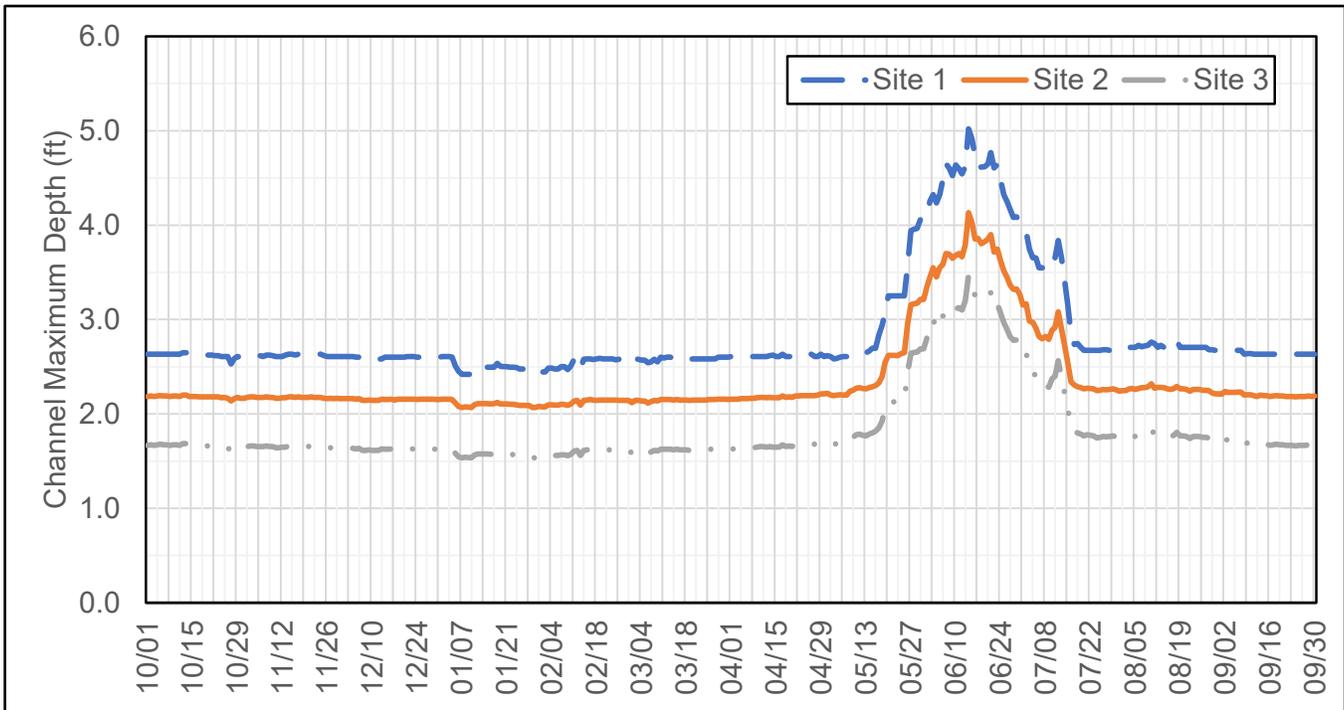
A time series analysis for average and maximum pool depths was completed to evaluate pool function during an average hydrologic regime, which is represented by the 50-percent-exceedance daily average flow between water years 1988 and 2021 (Section 3.1.3). Most of the year during this average hydrologic regime the average depth for all sites is less than 1.5 feet, except during runoff (Figure 46). Site 1 average depth is closest to the 1.5-foot threshold Winters and Gallagher (1997) identify as adequate for habitat. Maximum depth for all three sites is greater than 1.5 feet except Site 3 in January (Figure 47). The time series results are consistent with the evaluation at specific discharges, and these results support the recommendations concerning potential for physical modification of the channel to enhance pool habitat.

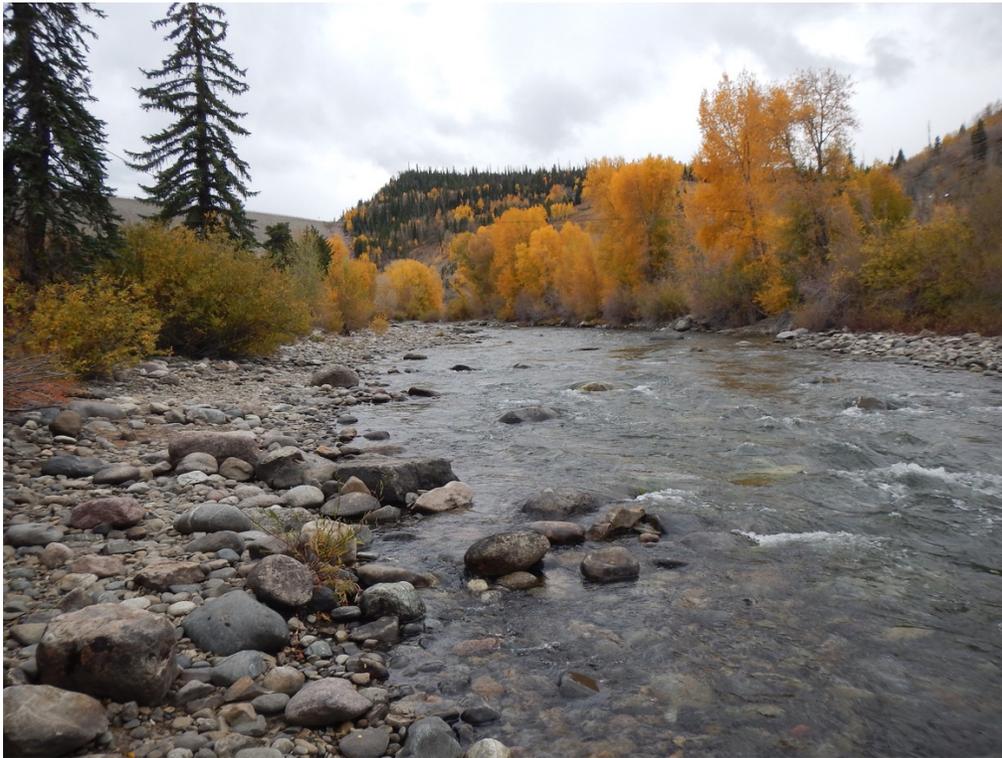
Figure 2. Site 1 looking upstream, September 29, 2021.

Site 1 is a relatively unmodified channel with a mixture of riffles, glides and pools. Stream substrate is dominated by cobbles and boulders (Figure 2 , Table 2). Habitat area for glides and riffles was almost equal at approximately 46% of the total area. Pool habitat area was approximately 7% (Figure 3). Average channel width ranged from 38.7 feet for riffles to 49.5 feet for glides. Residual pool depth was 2.4 feet (Table 1).
