Blue River Integrated Water Management Plan

Assessment of Current Aquatic Habitat in the Blue River below Dillon Reservoir, Subreach 2.2

July 2023

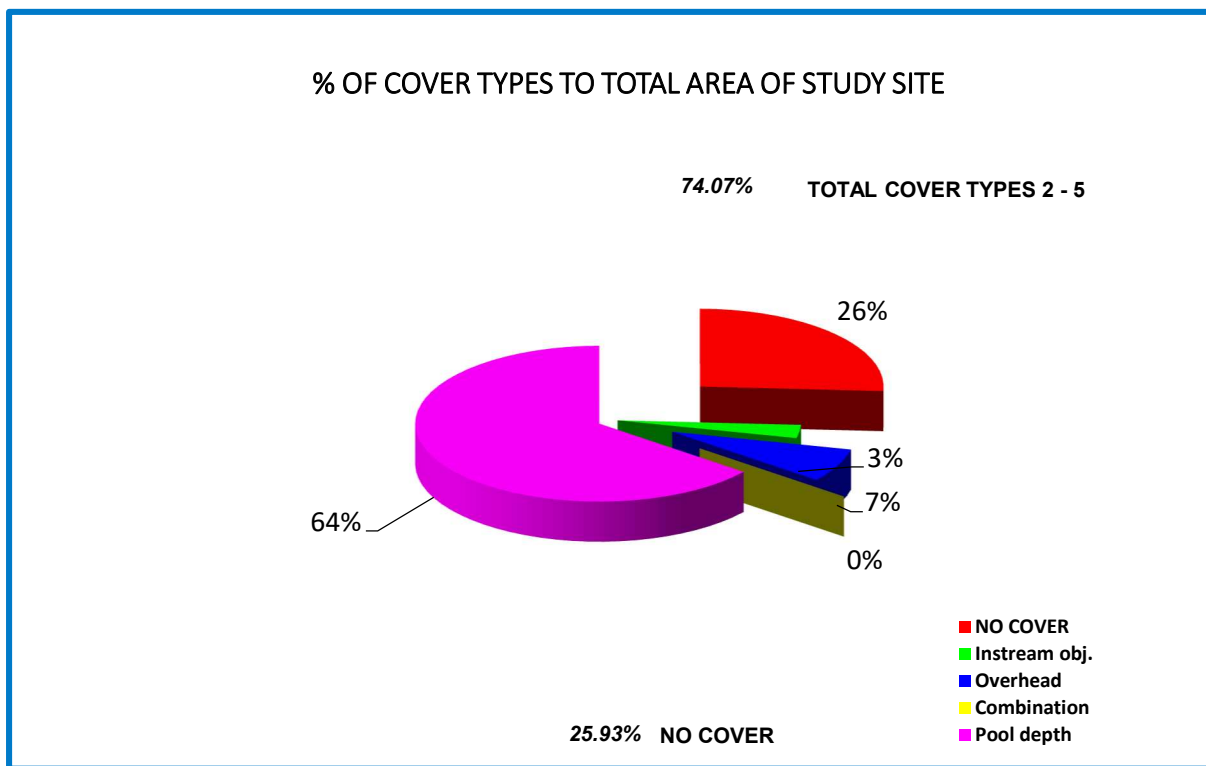
Figure 18. Habitat assessment Subreach 2.2, Site 4, Town of Silverthorne, percent cover by cover type.

Stream habitat at Site 4 is comprised primarily of pools (47.4%) and glides (39.9%). Pools were associated with the outside of the meanders seen in this area and averaged 2.0 feet deep (Table 5). Pool depth provides the dominant cover, with a limited overhead cover created by riparian willows. The channel substrate at Site 4 was predominantly small to medium size boulders and large cobbles (Table 4). Spawning gravels did not appear to be available in any quantities. Floodplain connectivity was limited to the point bars and a portion of the right overbank. Willows are encroaching onto the point bars. This site has the highest percentage of cover habitat compared to the other seven sites (Figure 18).

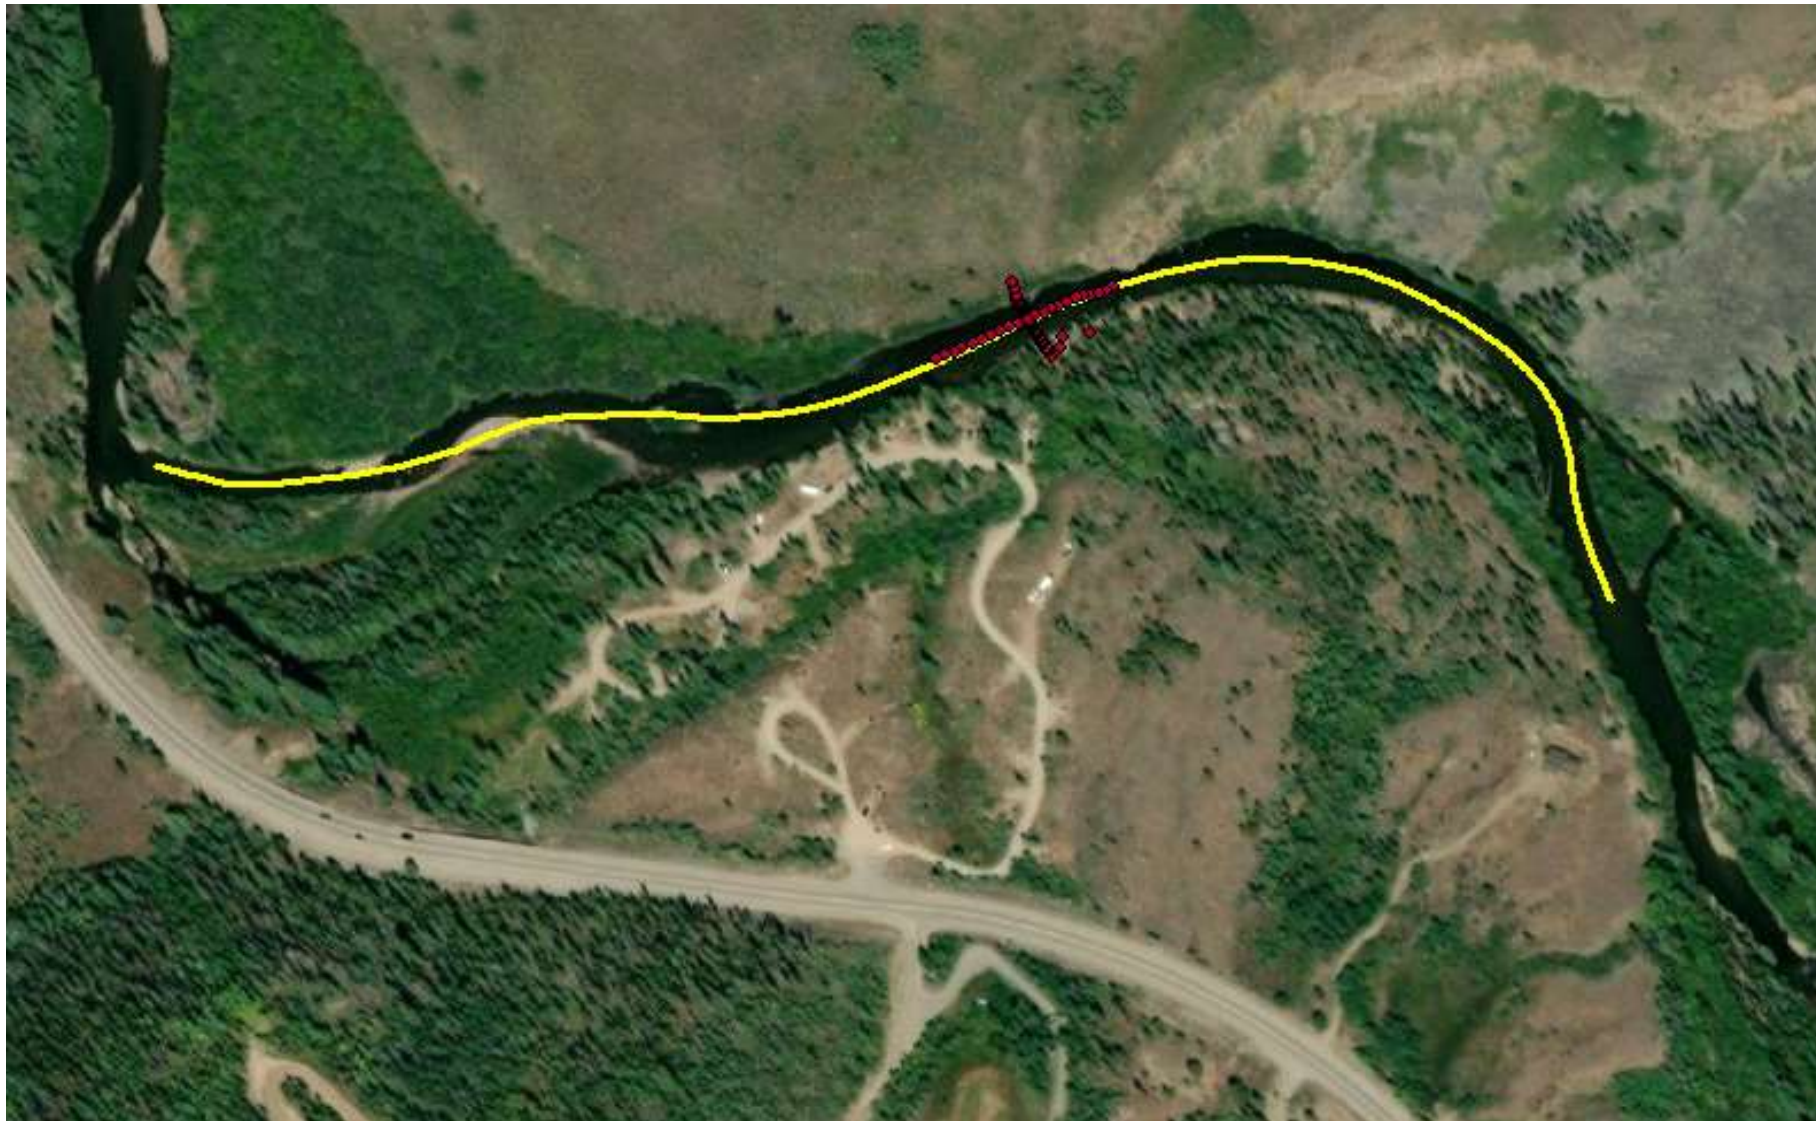
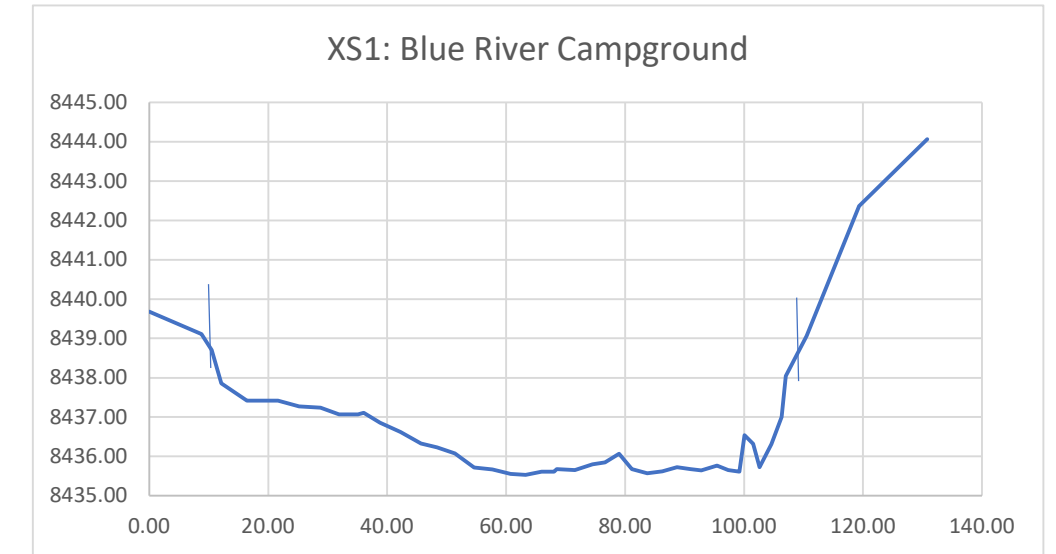
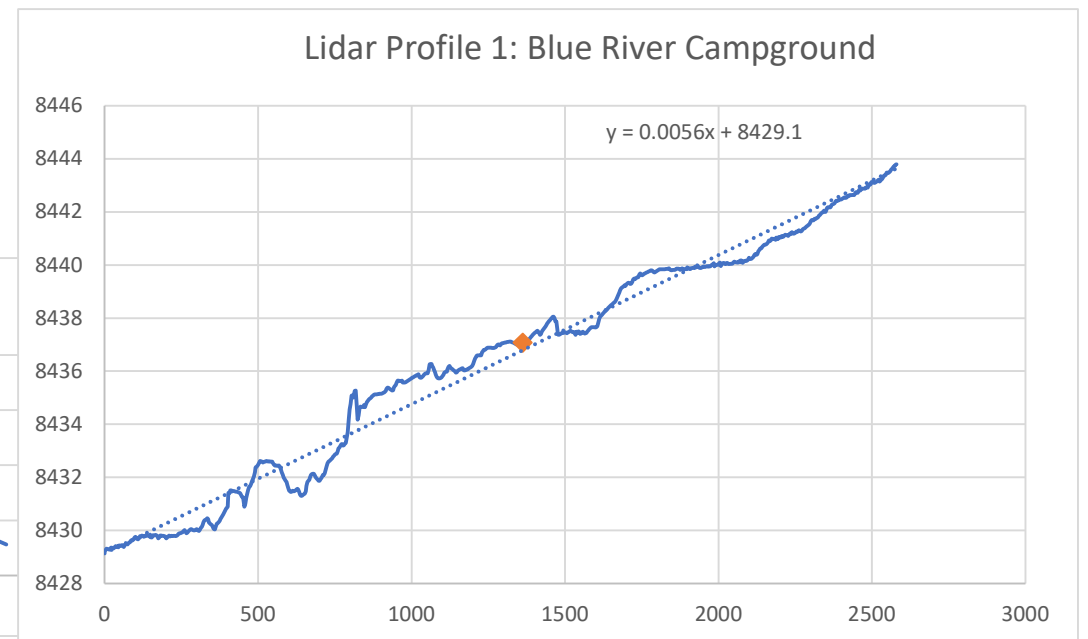
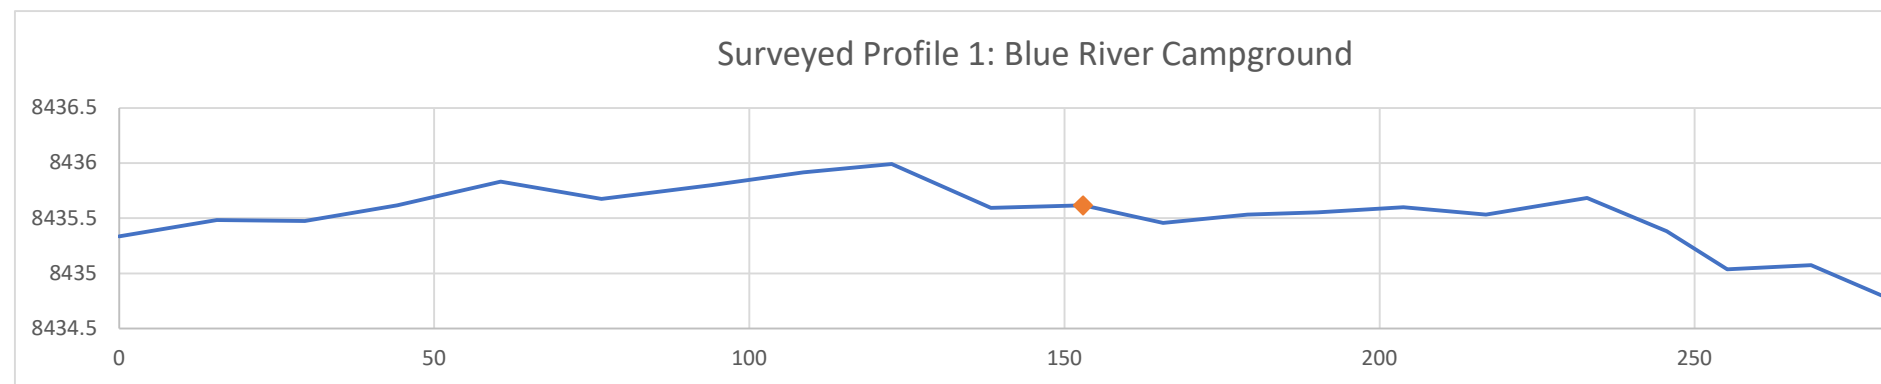
Site 8: Blue River Campground

Surveyed XS and Profile Points (Red points) and Lidar Profile Line (Yellow Line)

cross section looking downstream
bank to bank 108.9 ft
