## Blue River Integrated Water Management Plan

# Blue River Conceptual Restoration Master Plan Dillon to USFS Campground

July 2023

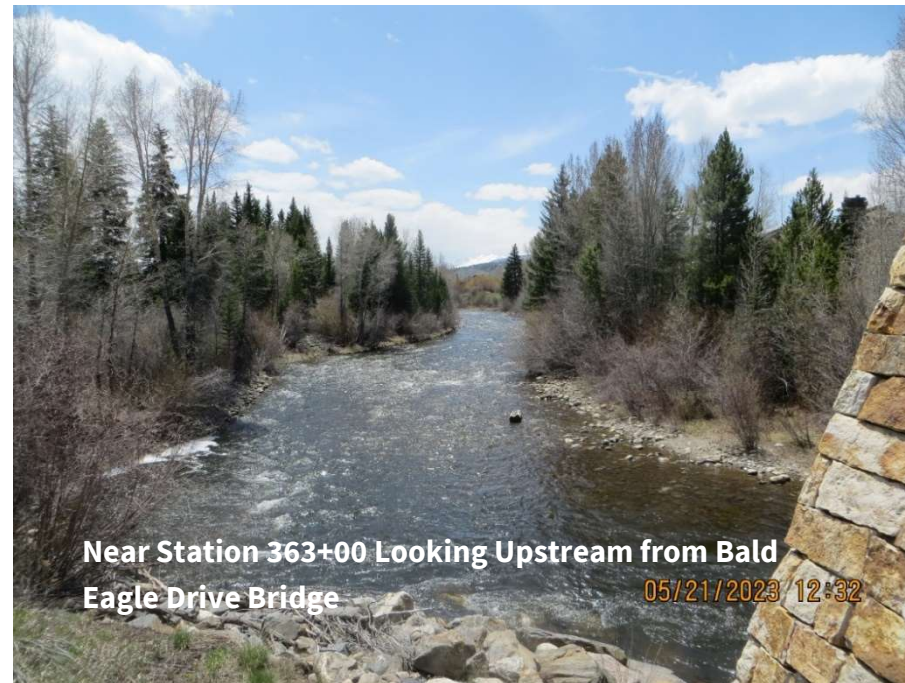
Near Station 363+00 Looking Upstream from Bald Eagle Drive Bridge  
 05/21/2023 12:32

Consider the addition of boulder clusters and large woody debris to diversify habitat within the channel and along the banks, and to help sort and retain spawning gravels should they be added

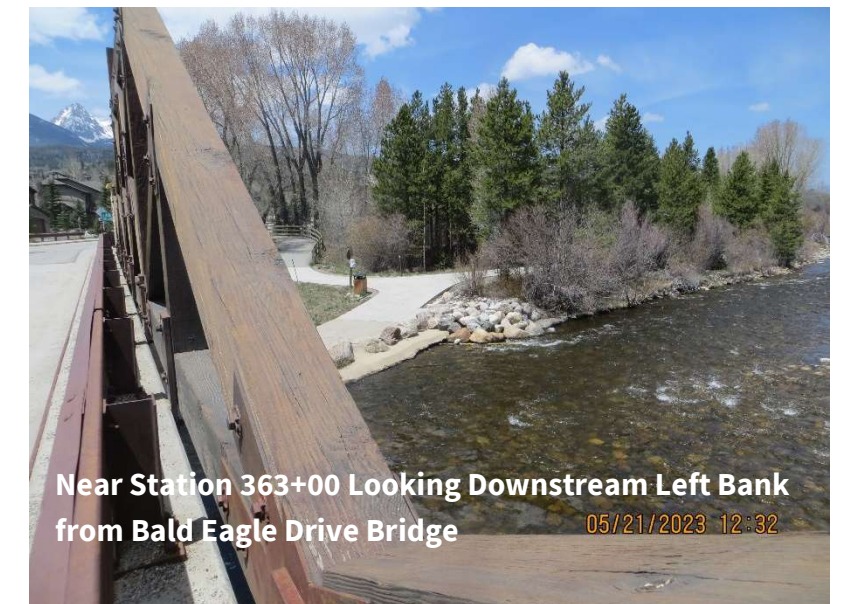
Near Station 363+00 Looking Downstream Left Bank from Bald Eagle Drive Bridge  
 05/21/2023 12:32

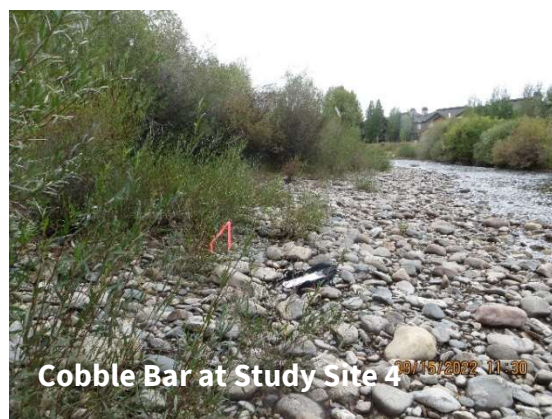
Cobble Bar at Study Site 4

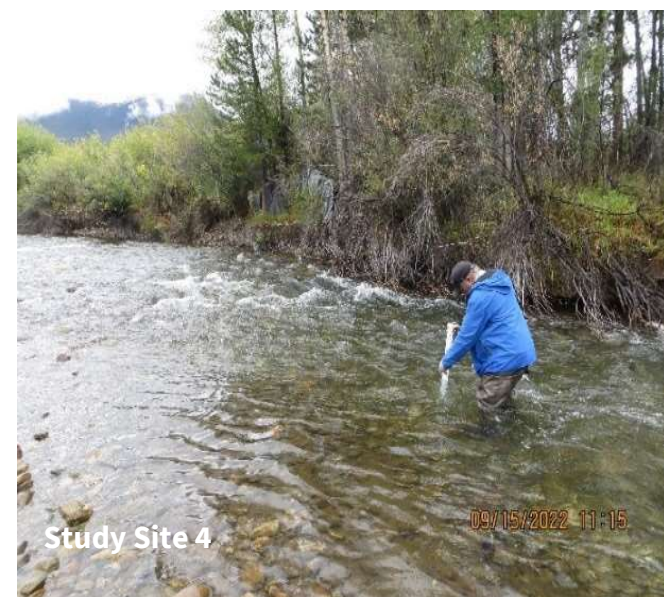
Study Site 4

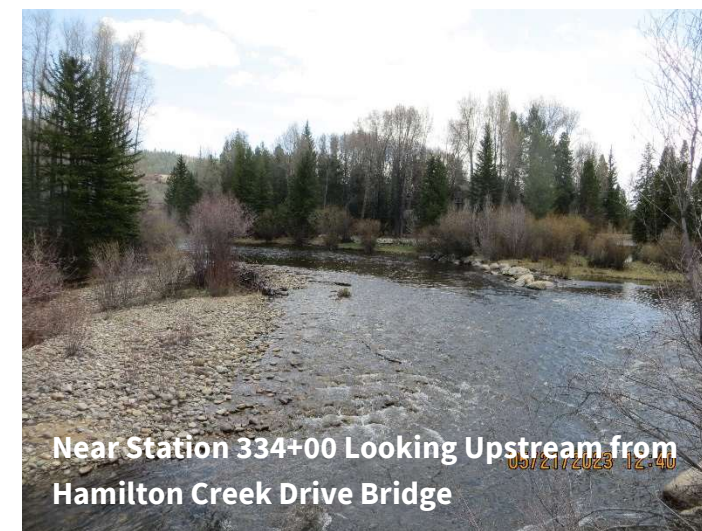
Hamilton Creek Road crosses the river near Station 334+00. Immediately upstream of the bridge, there is a large deposit of gravel. While this gravel deposit does not notably impair aquatic habitat, it is likely decreasing the bridge capacity as reflected in the current FEMA floodplain mapping (FEMA 2023). Should improvements be contemplated at this bridge crossing, consider fish-friendly techniques such as flow deflectors, reconfiguring the channel bar, and deepening the pools. Velocities through the bridge should also be reviewed.

Near Station 334+00 Looking Upstream from Hamilton Creek Drive Bridge

Restoration recommendations include improvements at the upstream section of the Hamilton Creek Road bridge to increase the bridge capacity while maintaining fish passage. In addition consider the addition of boulder clusters and large woody debris to diversify habitat within the channel and along the banks, and to help sort and retain spawning gravels should they be added

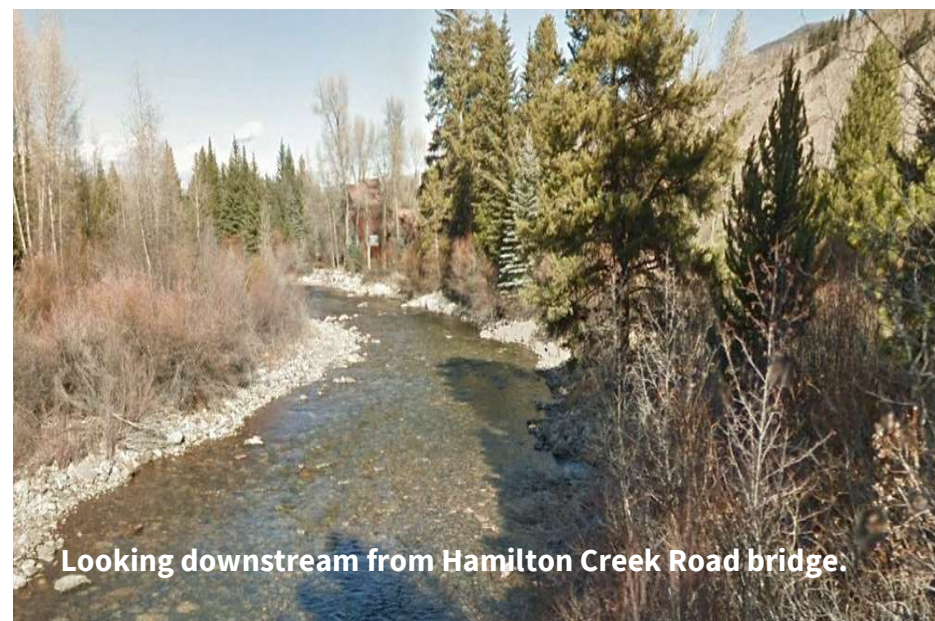
Looking downstream from Hamilton Creek Road bridge.

Restoration recommendations include the addition of boulder clusters and large woody debris to diversify habitat within the channel and along the banks, and to help sort and retain spawning gravels should they be added.

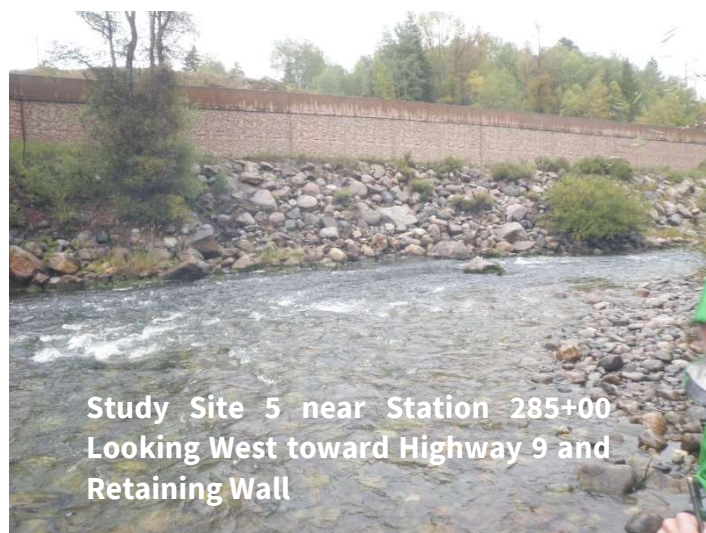
is a significant reduction in cover and the stream is wider compared to Site 4. This site is approximately one-quarter mile downstream from the Blue River Wastewater Treatment Plant, and increased nutrients are evident in the form of algae on the channel substrate. The substrate is slightly embedded due to sediment additions from winter sanding operations on State Highway 9. The residents in the subdivision stock the river in this area to maintain fishing quality.

Study Site 5 near Station 285+00  
 Looking West toward Highway 9 and Retaining Wall

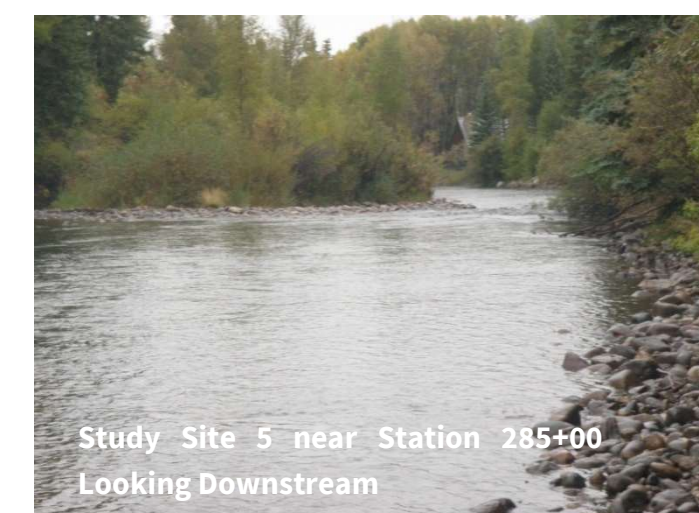
Study Site 5 near Station 285+00  
 Looking Downstream

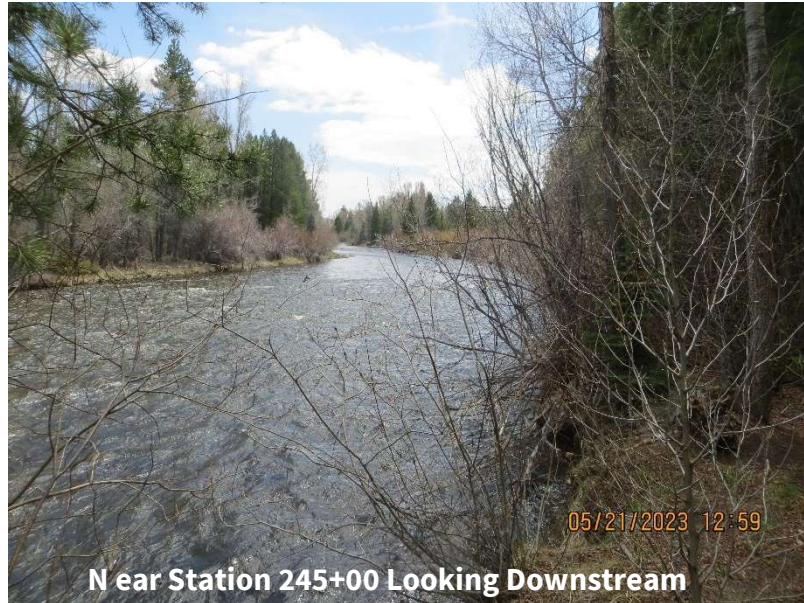
Near Station 245+00 Looking Downstream

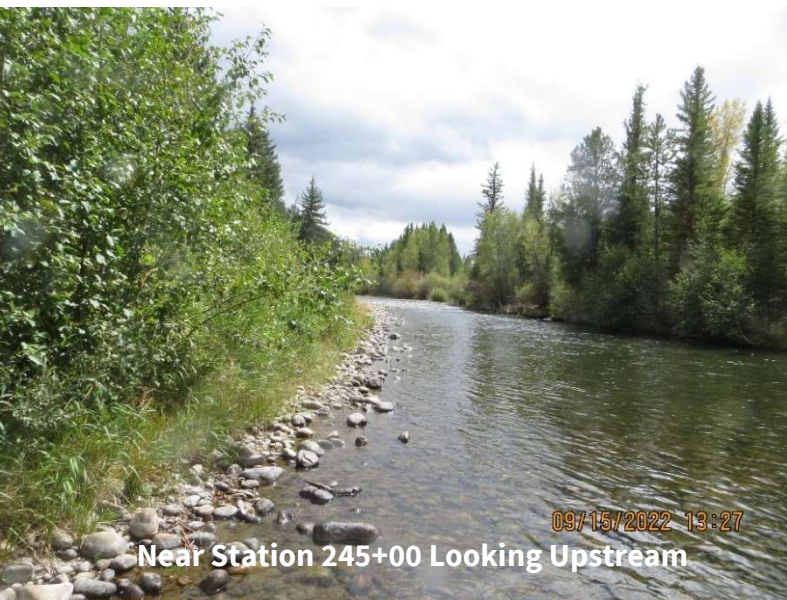
Near Station 245+00 Looking Upstream

This section of the river appears to have retained much of its morphology compared to the 1954 aerial imagery, including several side channel channels and a wide floodplain. Vegetation density appears to have increased in the side channels, creating a prevalent single-thread

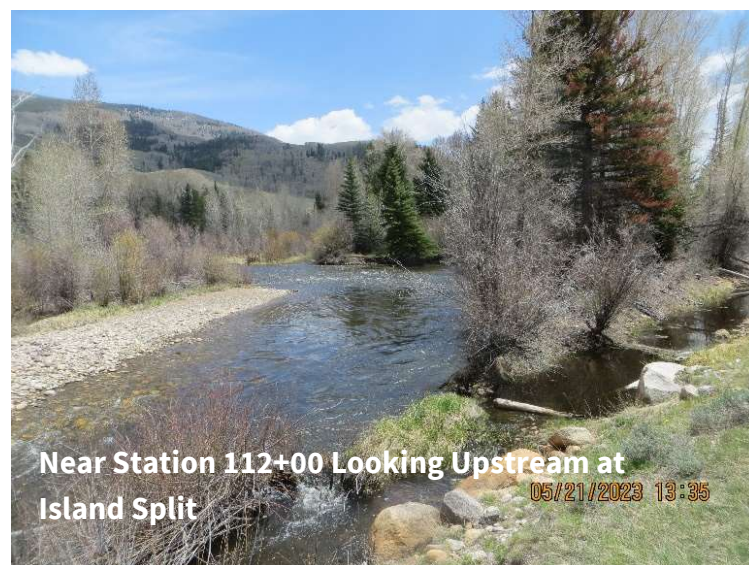
Near Station 112+00 Looking Upstream at Island Split

There is one large pond east of the river and floodplain. This pond appears to have a spillway discharging into a side channel between Stations 109+00 and 119+00. There are large unvegetated cobble deposits present at this discharge point which may be in part due to the spillway and pond. A review of available aerial imagery indicates a notable increase in unvegetated gravel bars up and downstream of the spillway. A more detailed analysis would be required to determine the causes of these deposits and possible impacts if any from the pond.

Immediately upstream of the CR 1870 bridge the right channel bank is degraded and notably wider compared to upstream. There is a 500 stretch of the river between Stations 112+00 and 117+00 that abuts State Highway 9, confined by bedrock outcrop. Here the river is narrower and the banks have been stabilized with riprap. There is an existing gravel bar near Station 116+50 that nearly spans the channel. This bar should be shaved, or narrowed, to allow for a wider channel section adjacent to State Highway 9 and this critical bend in the river.

1. Remove the grade control structure at Station 126+25, regrade and narrow the channel, and reconstruct the right channel bank.
2. Partially excavate or shave the existing gravel bar at station 116+50 to increase capacity at the narrow bend near the highway. Consider additional bank protection such as bank armoring, flow deflectors, or spurs on the left bank immediately adjacent to the highway.
3. Add a point bar to narrow the channel upstream of CR 1870.

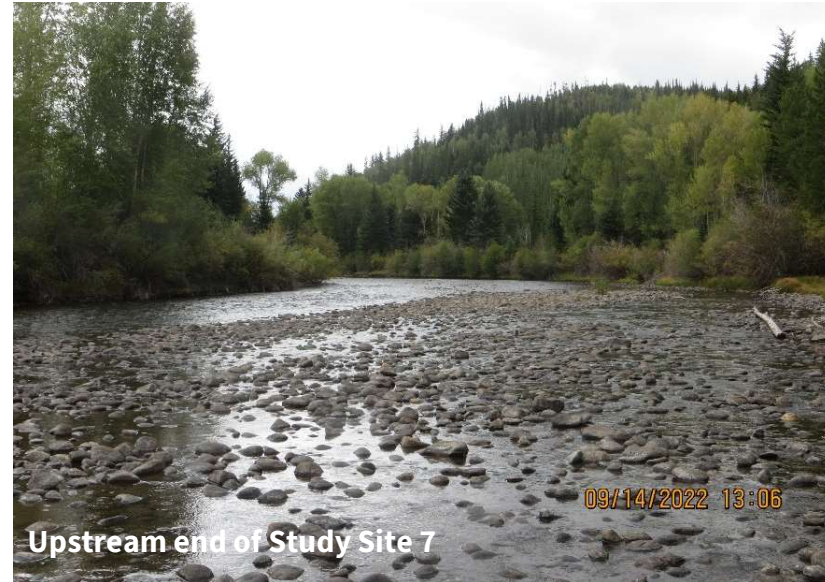
Upstream end of Study Site 7

evident than the upstream reaches at low flows. The left overbank and the channel show evidence of gravel and boulder deposits or mounds, lack of organic material, and little vegetation except for newly recruited lodgepole pine. Some of these deposits appear similar to the deposits created by gravel mining, however, further review indicates that this area may have been exposed at one time to a debris or avalanche event from the west drainage, resulting in these gravel deposits and contributing to an overly wide channel.

1. Construct river trails in the areas depicted on the plans.
2. Narrow channel using cobble point bars.
3. Deepen existing pools and construct new pools on outer banks.
4. Consider the addition of wood, boulder clusters, and native vegetation along banks.
5. Revegetate and stabilize damaged channel banks.
