SWAN RIVER RESTORATION PRELIMINARY DESIGN PLAN REPORT

March 22, 2013

ERC Project # 860-1201

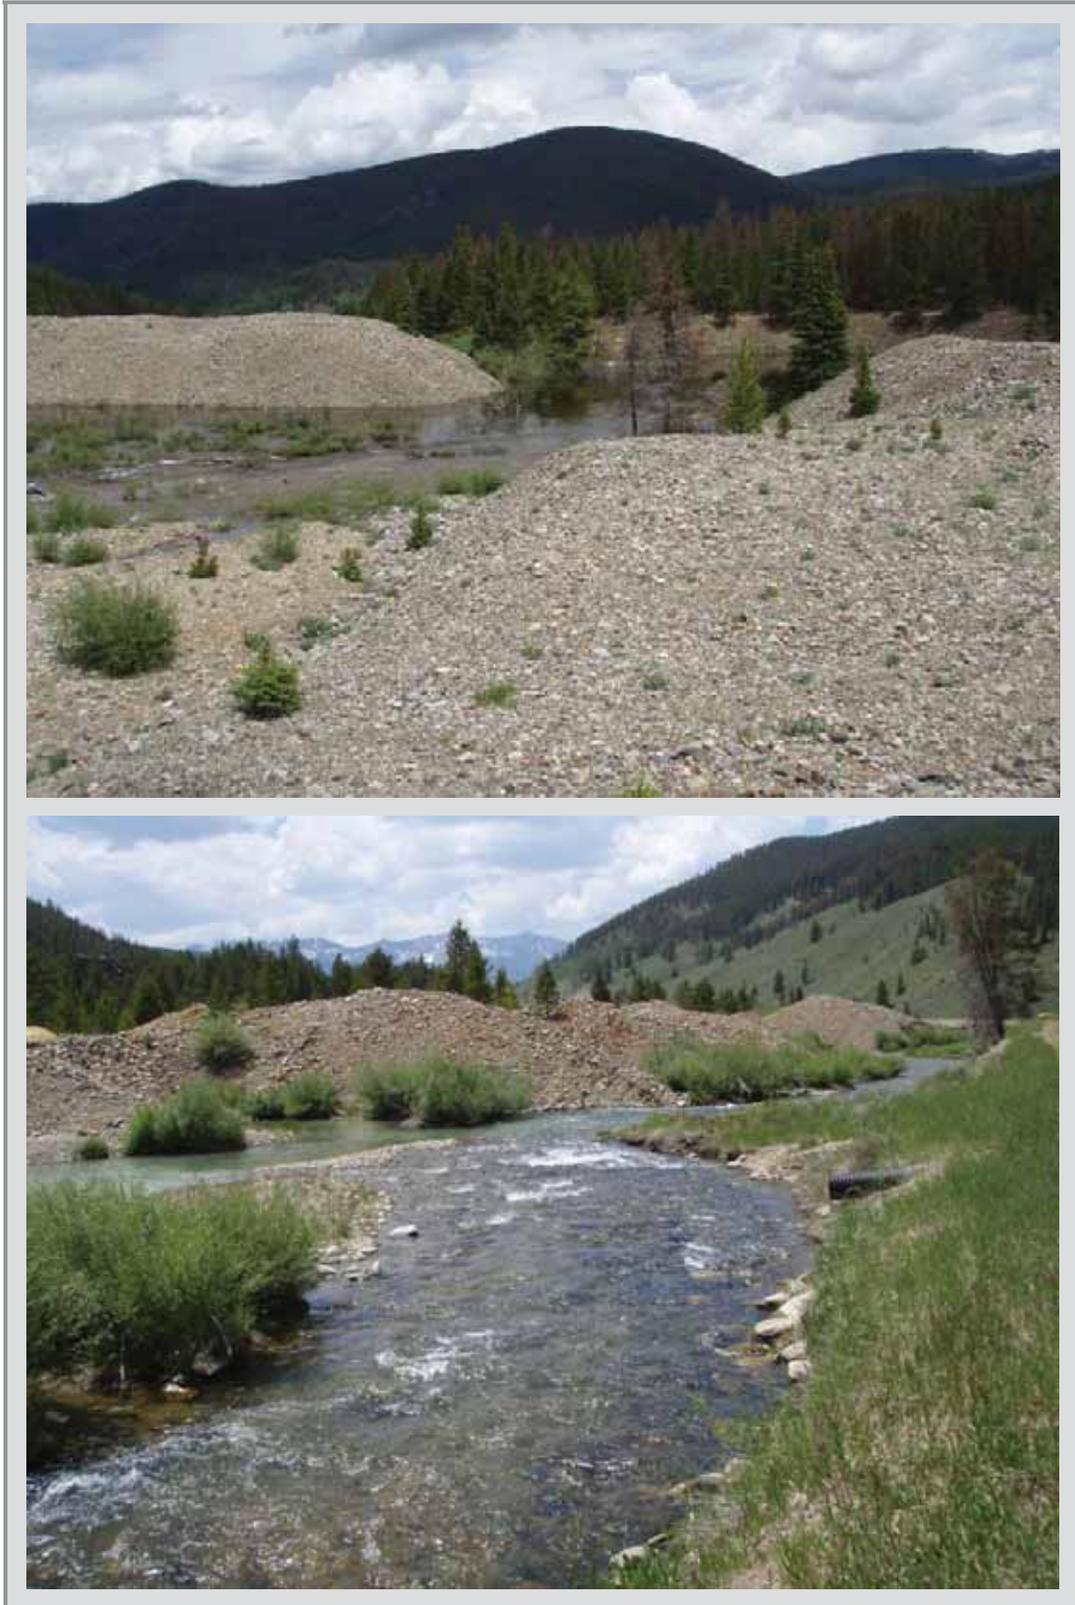
Figure 2.4. Existing Dredge Piles and General Site Characteristics of the Project Area.

The Project Area has been historically mined using placer mining techniques. Dredging was completed to an unknown depth throughout the Swan River Valley as well as the nearby Blue River Valley. Dredge spoils remain on the Project Area and typically consist of sand to cobble sized materials left in piles that extend approximately 25 feet above the surrounding valley floor. The entire Project Area is generally devoid of natural vegetation and ecological function as a result of past mining activities. Sporadic pockets of shrubs or young trees may exist near the existing Swan River channel or where groundwater surfaces. In portions of the Project Area, dredge material has been removed or is currently being removed and sold commercially. A majority of the dredge material that has been removed from the valley for commercial purposes was located in the lower portion of the Project Area within the 2009 County Plan area. The stream has been channelized in large part by the mining process and natural riparian areas are minimal to nonexistent throughout the Project Area. Removal of the dredge material and restoration of a natural stream and riparian system are the primary focus of this Preliminary Design Plan. **Figure 2.3** and **Figure 2.4** show historic and present conditions in the project area.

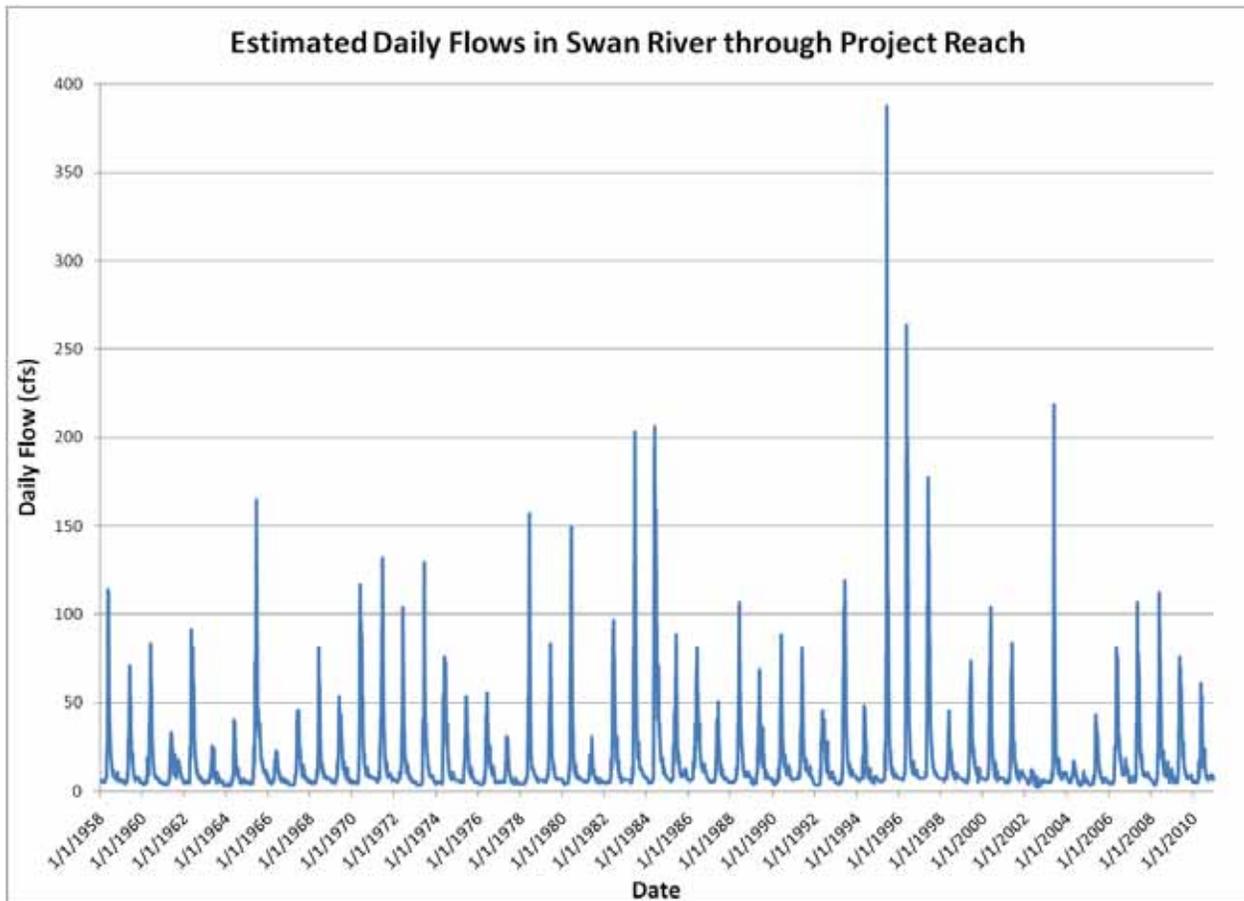
Figure 3.1. Estimated Daily Swan River Flows.

Flow estimates for the Swan River were then made based on available data from Keystone Gulch from 1958 through 2010. Daily flows measured at Keystone Gulch were multiplied by 2.53 to adjust flows from this 9.10 square mile basin to estimate daily flows at the Project Area. Estimated daily flows through the Project Area over this 53 year period of record are shown on **Figure 3.1**. Note that a straight basin adjustment was used for these daily flows. Unlike flood flows where additional adjustment is often used, a straight basin ratio was taken when looking at daily data following the idea that the unit runoff from both basins would be similar.

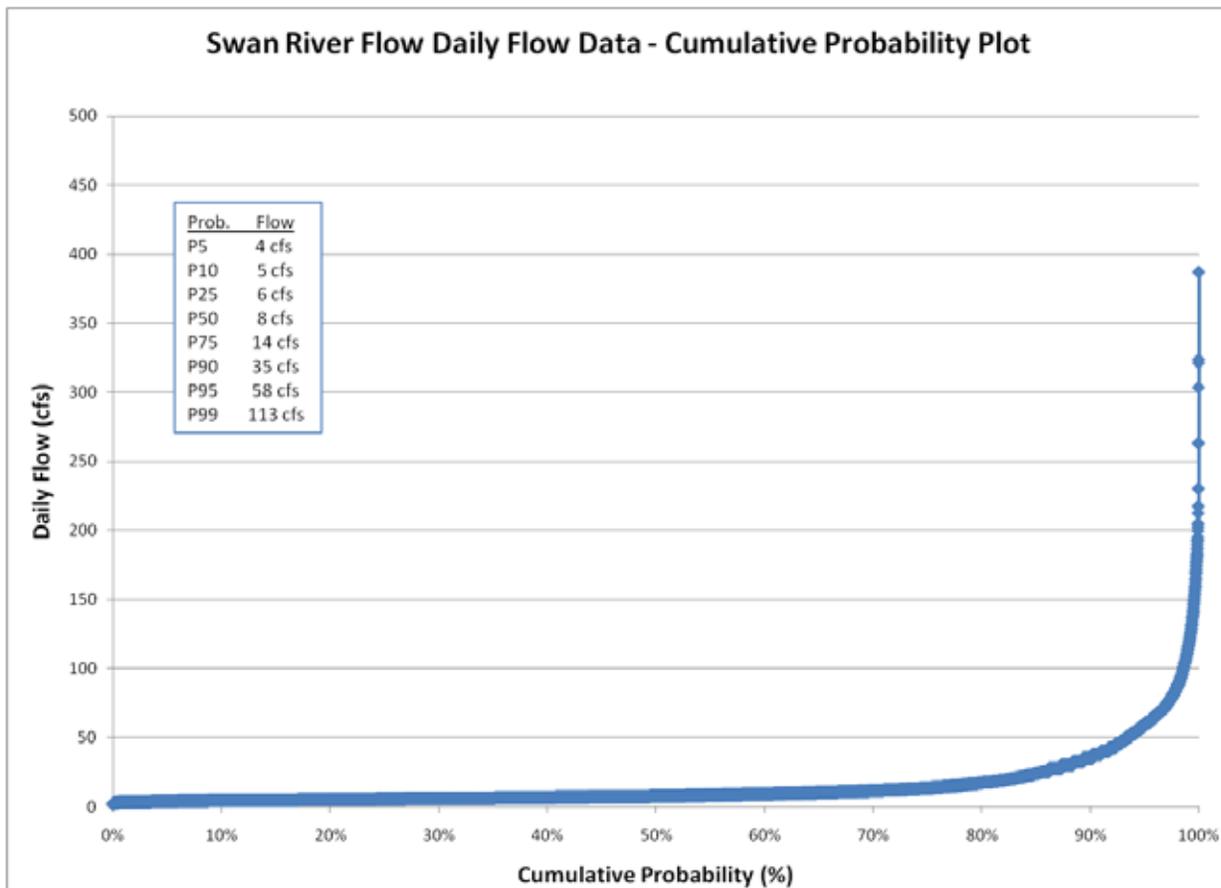
Figure 3.2. Cumulative Probability Plot – Daily Flows.

As would be expected, flows show a definite seasonal trend with peak flows occurring as the result of spring runoff. Flows through the late fall and winter are typically the lowest. A cumulative probability plot of estimated daily flows was developed to quantify the percentage of times flows are less than a given flow magnitude. Results of the flow frequency analysis are shown on **Figure 3.2**.

Results indicate that 5% of the time, flows are predicted to be at or below 4 cubic feet per second (cfs) based on extrapolation from the Keystone Gulch gage. Flows are expected to be at or below 8 cfs 50% of the time and at or below 58 cfs 95% of the time. Over the 53 years flows are estimated to range from a low of approximately 2.2 cfs to a high of 390 cfs.

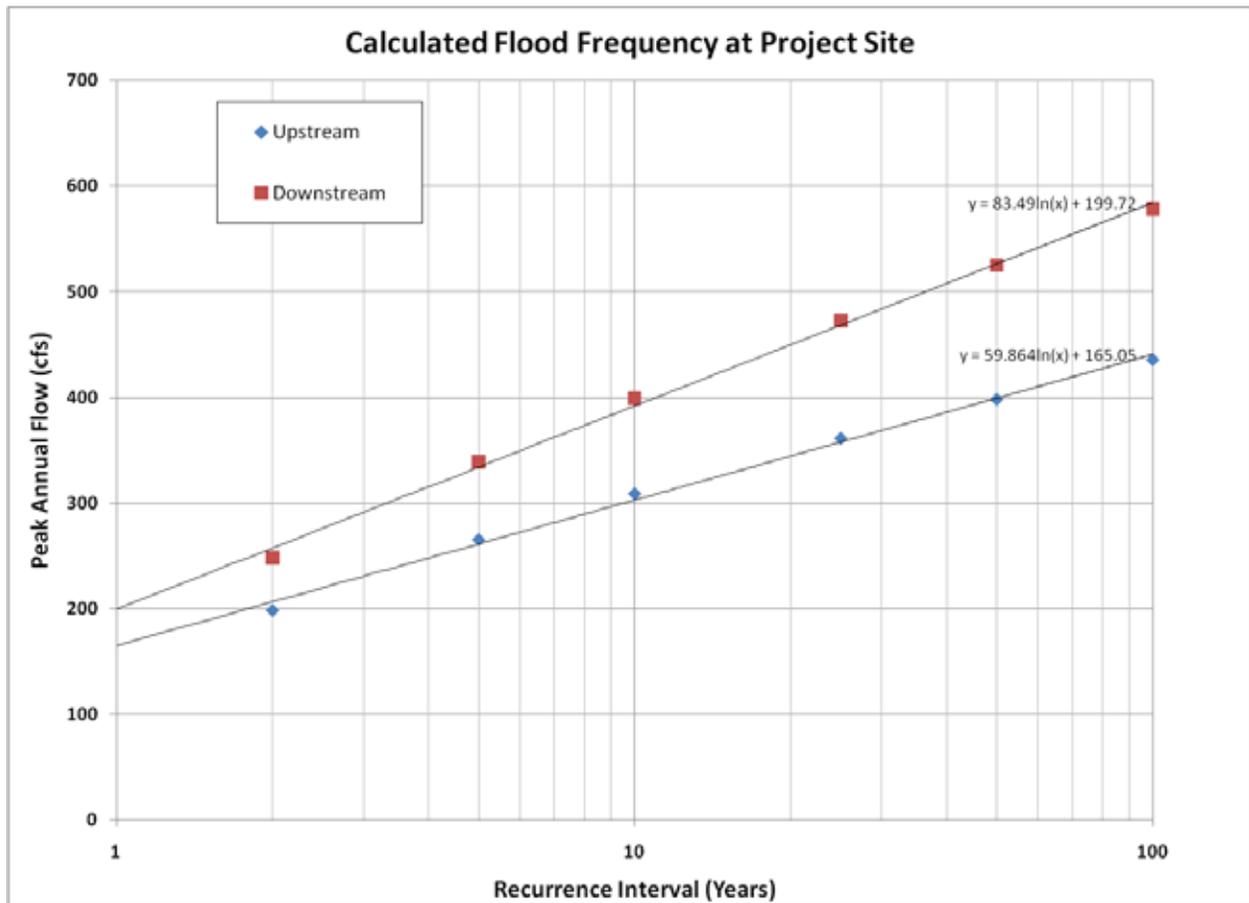
Figure 3.3. Estimated Flood Flow Frequencies at the Project Site.

the restoration design, the bankfull flow is intended to be the point where bank vegetation will be established. **Figure 3.3** shows the flood flow values calculated by the Vaill method for both the upstream and downstream project reaches, extrapolated to include the 1.5-year flood event. Based on this information, the bankfull flow is assumed to be on the order of 190 cfs – 230 cfs.

There is an inherent uncertainty in the estimate of bankfull flows at an ungaged location. Errors are greater for the more frequent flood events and range from 59.6% for the 2-year event to 43.4% for the 100-year event (Vaill 2000). A number of checks on this important design input were therefore performed as part of the preliminary design. One check included review of available references to check estimates of larger flows against flow estimates at the other gages. A second check involved field surveys and hydraulic modeling to estimate bankfull flow further downstream on the Swan River.

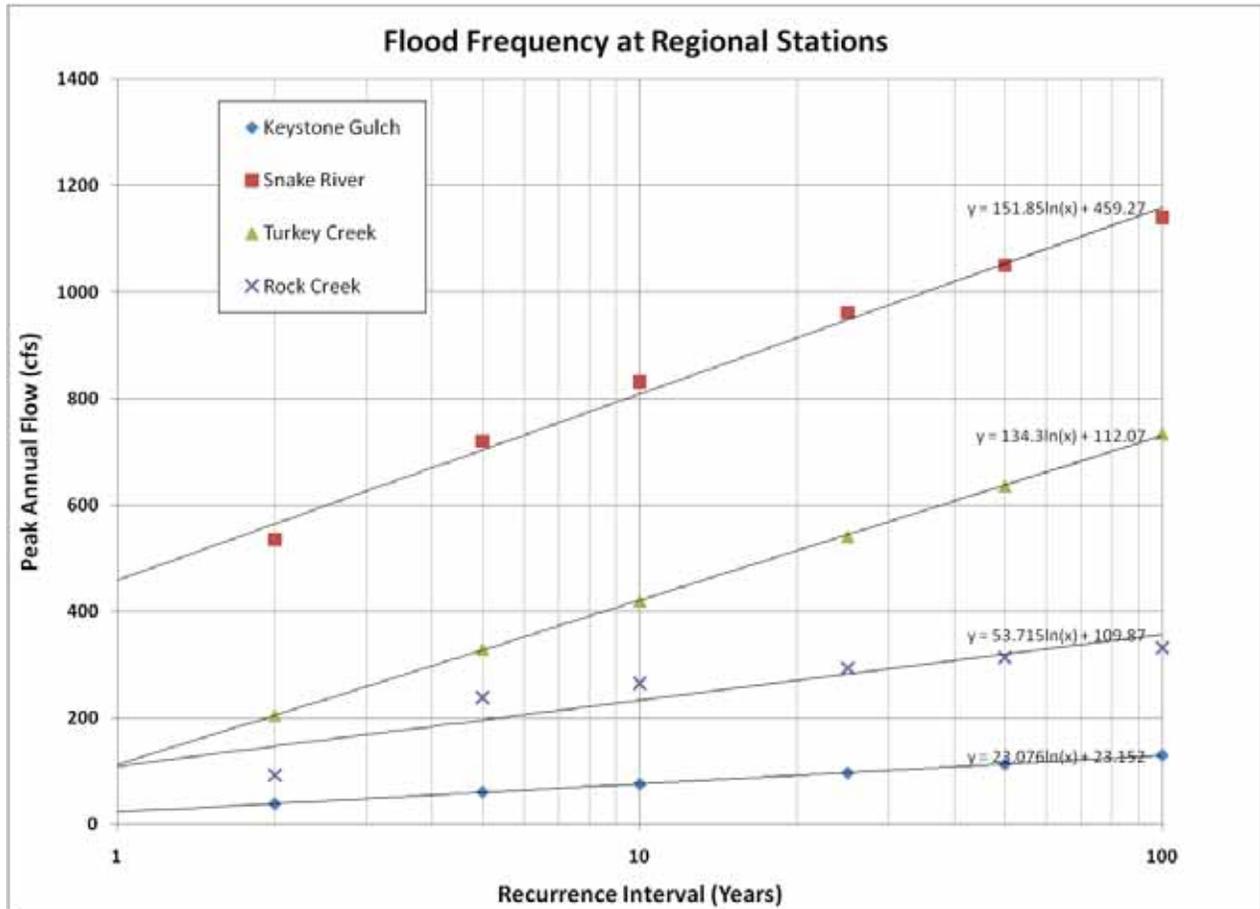
Figure 3.4. Estimated Flood Flow Frequencies at Regional Station.

As a first check on the numbers presented above, peak flows were estimated based on data from Keystone Gulch, the Snake River, Rock Creek and the Turkey Creek gage sites. At each of these locations peak flow estimates contained in the Vaill 2000 report were compiled. The 1.5-year event at each location was extrapolated using probability plotting based on estimated flows. A graph showing plotted

flood frequency data for each of the four sites is provided in Figure 3.4. Results using these various locations are summarized in Table 3.2.

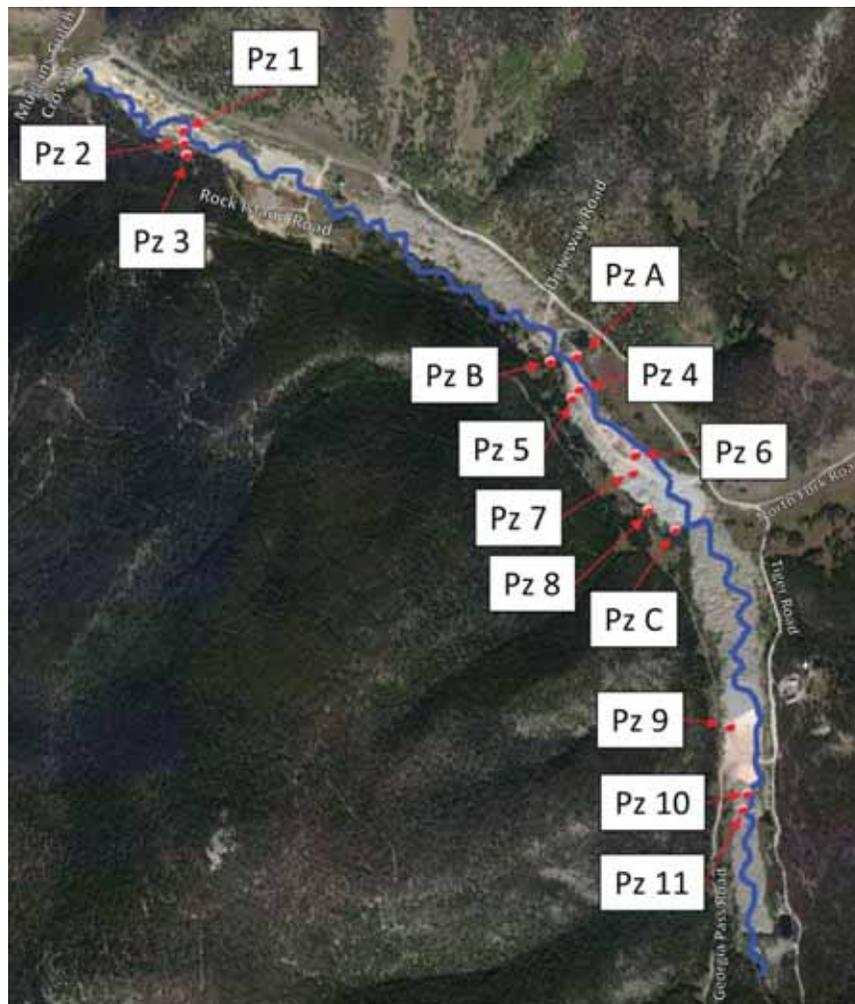
Figure 3.5. Locations of Ground Water Piezometers.

Given that the existing stream runs subsurface through the Project Area, obtaining a better understanding of groundwater levels was an important aspect of the preliminary design process. A series of 14 piezometers were installed by the Everist Materials, LLC and monitored by the Forest Service at locations intended to provide spatial coverage of the Project Area while considering access and current topography created by the dredge piles. The locations where groundwater was measured from piezometers are shown on Figure 3.5.

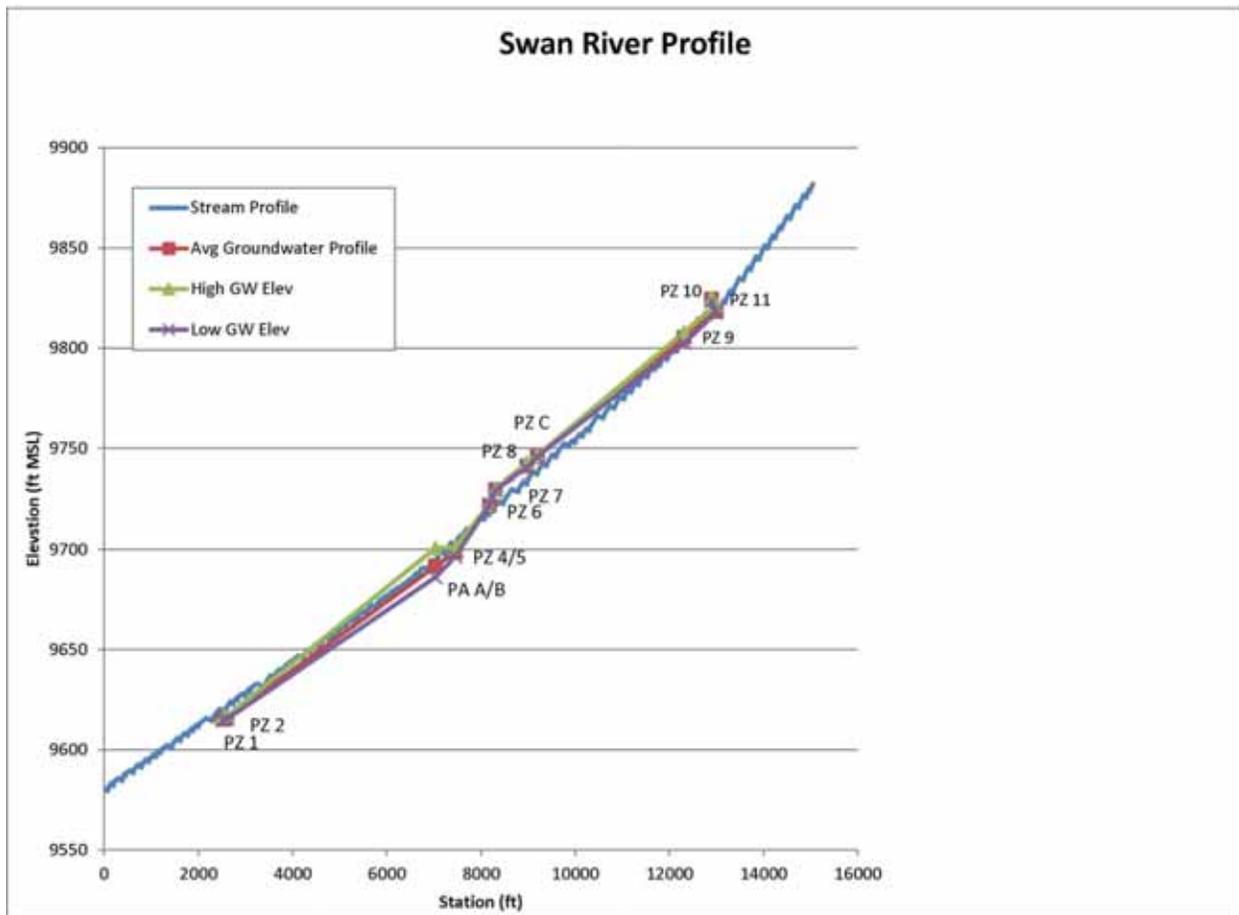
Figure 3.6. Groundwater and Stream Profiles.

Readings were taken by the Forest Service and consisted of 18 water depth measurements from each of 14 separate piezometers. Measurements were taken approximately weekly between June and November 2012. Raw data were compiled into highest, lowest, and average groundwater elevations in each piezometer over the sample period. These elevations were plotted in profile with the proposed stream elevation by matching piezometers to the closest stream station. This plot is shown in **Figure 3.6**. It should be noted that ERC projected groundwater elevations to the stream location, so some variability is inherent in this figure. Graphs displaying the temporal variation in water levels at the different piezometers are included in **Appendix A**.

A comparison of the proposed stream profile with the groundwater levels indicated that in general the two surfaces are quite similar but at certain locations and times the groundwater levels appear to be below the proposed stream bed. This is particularly true in the downstream section of the project in the vicinity of PZ 1 and 2 (near STA 25+00), and PZ 4 and 5 (near STA 74+00). In these locations stream bed elevations are generally 1-4 feet higher than the highest groundwater elevations. In general, groundwater levels appear to be lower than the proposed streambed in the vicinity of piezometers

downstream of Driveway Road. Groundwater levels in these piezometers generally showed very minimal variation during the period when data was collected and suggest that average groundwater levels may be approximately 2-6 feet below the proposed streambed at these locations.

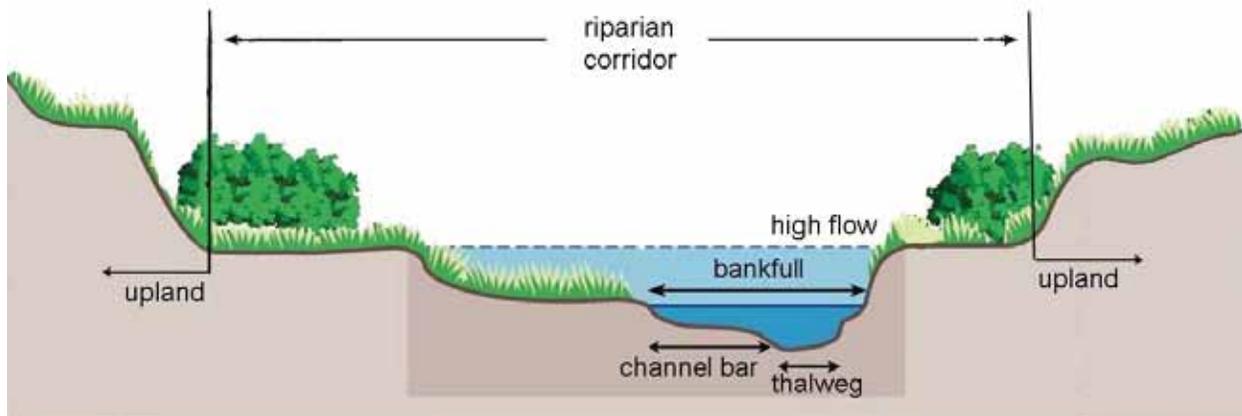
Figure 4.1. Schematic of Stream and Adjacent Lands in a Natural System.

As part of this approach, design concepts considered improvements to the channel and the connection between the stream and adjacent lands. Improvements recommended as part of this Preliminary Design Plan include an appropriately sized channel to convey typical and bankfull flow events, a riparian corridor and transitions into upland areas. A schematic showing the relationship between the stream and adjacent lands considered in this Preliminary Design Plan is presented in Figure 4.1.

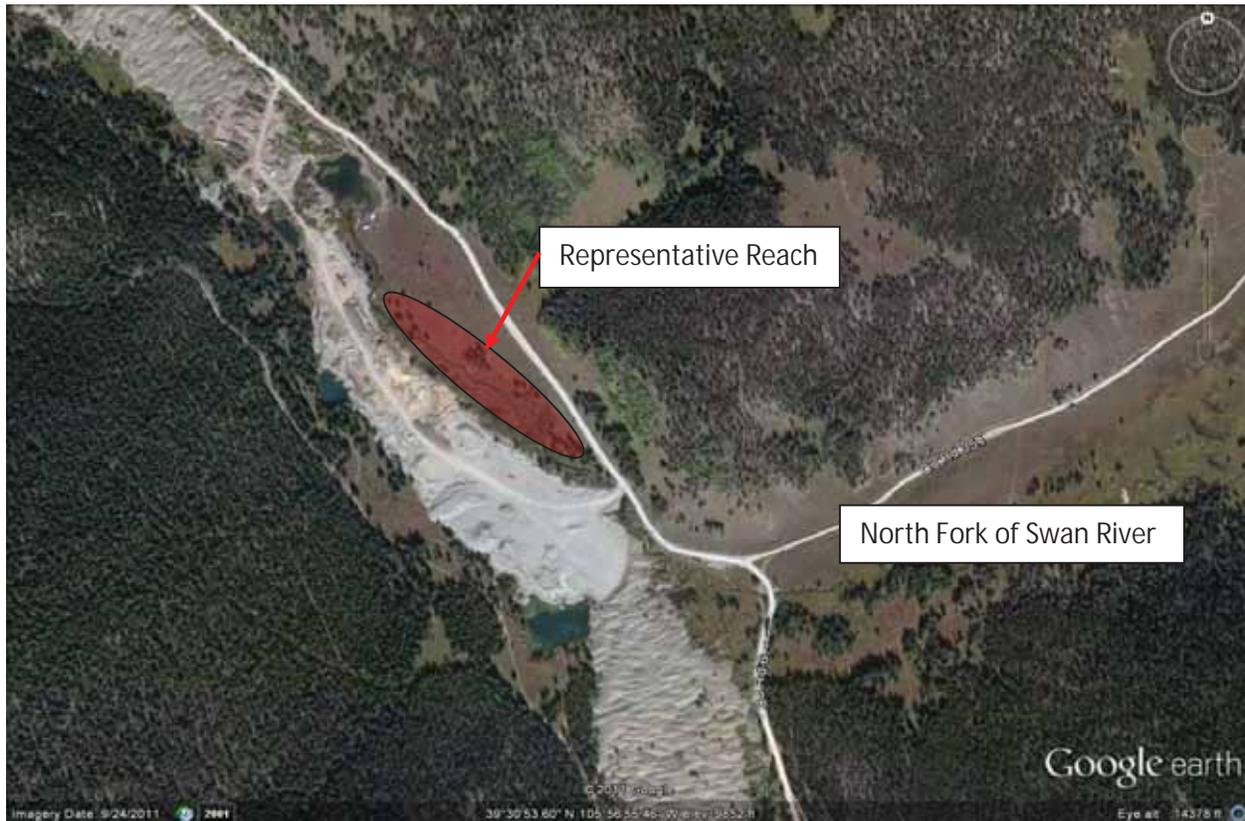
Figure 5.1. "Representative Reach" within Project Area.

Existing bankfull channel widths were measured at five locations within this representative reach by ERC as part of a site investigation in September of 2011. All bankfull measurements ranged from 20 – 25 feet. Measured bankfull widths are within the general range of the widths estimated based on standard geomorphologic data indicating a good relationship between widths estimated from standard geomorphologic principles and those measured in the field. Results lead to the design geometry of 25 foot bankfull width in riffle sections. Bankfull stream widths for the riffles sections and in pool and glide sections (areas between riffles) were then further refined through the use of hydraulic modeling.

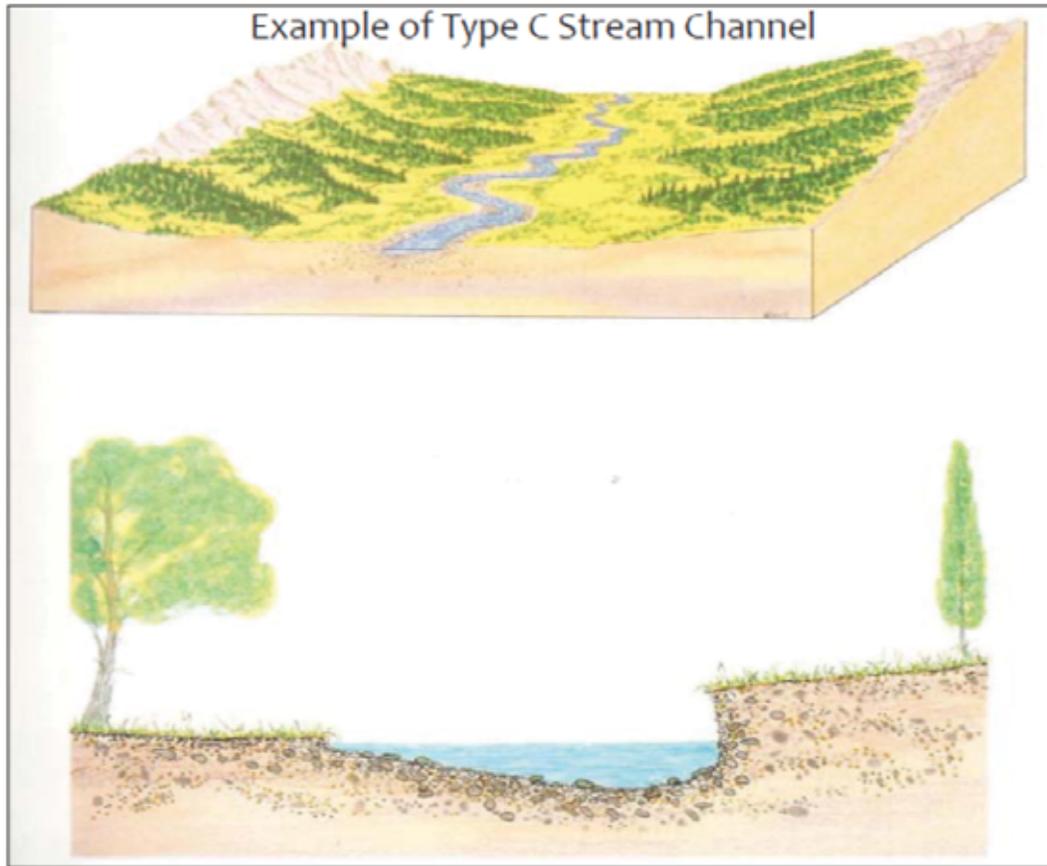
Figure 5.2. Schematic of Typical Type C Stream.

Channel planform, or shape as observed from above, was estimated based on the stream type that is assumed to be appropriate through the Project Area. As part of this assessment other regional streams were evaluated and it was found, as would be expected, that a majority of healthy streams in this area are single thread systems. Given this and the broad, terraced valleys observed in other segments of the Swan River, ERC believes that a Rosgen Cb Stream Type is an appropriate target for the restored channel segment. A Type Cb stream is a single thread channel alluvial stream, as shown in **Figure 5.2**. It typically includes a meandering planform with point bars and riffle/pool sequences and has a broad, defined floodplain.

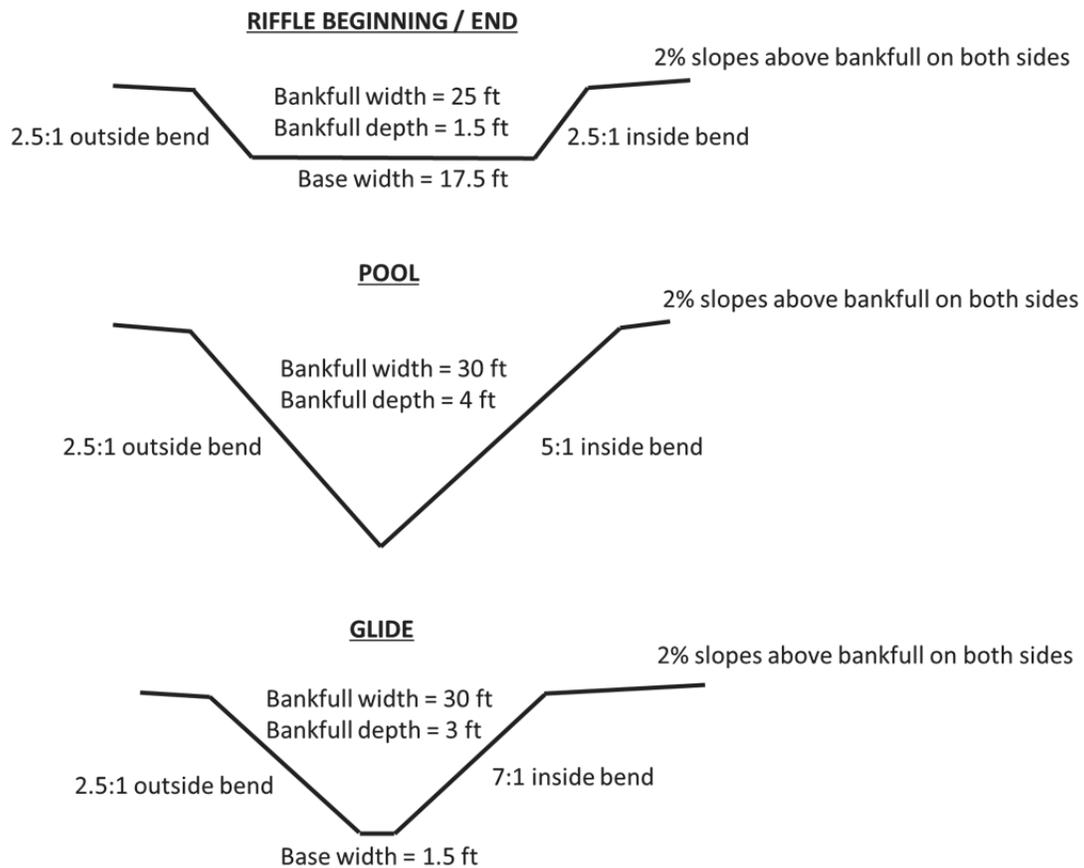
Figure 5.3. Channel Cross-Section Geometry by Feature.

Results obtained by the model suggest that the flow depth in the riffles in the upstream and downstream reaches will be in the range of 1.4 – 1.6 feet. Flows were calculated to be subcritical. The cross-sections for each of the features are depicted in **Figure 5.3**.

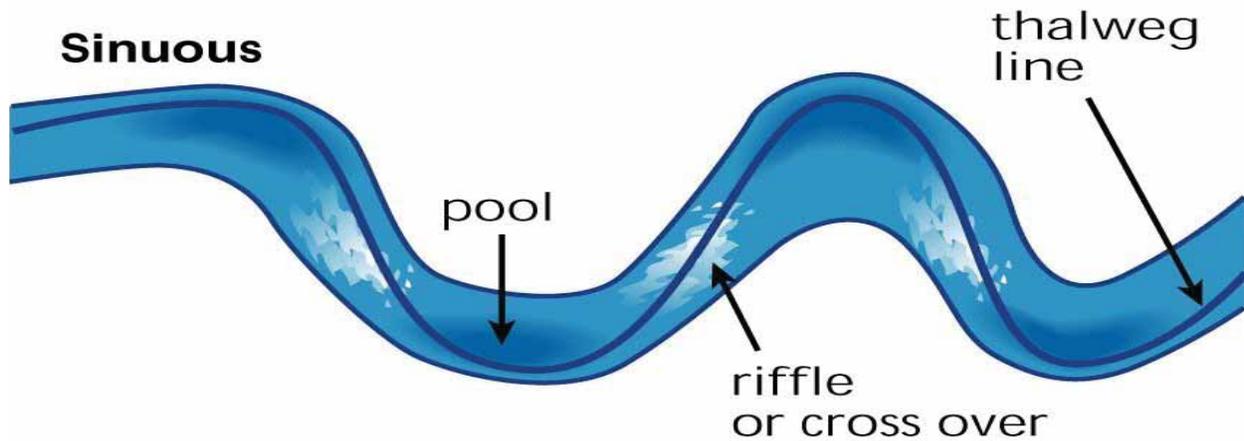
Figure 6.1. Schematic of Meandering Channel with Riffle/Bend Pools.

A plan view of the proposed channel is presented on **Sheets 2-8** in **Appendix D**. A key element of the proposed channel design is creating a meandering pattern that is in balance with the natural hydrograph. The proposed channel takes on an alignment that is generally meandering through the valley, as shown in **Figure 6.1**. It has an overall sinuosity of 1.28 and follows a non-uniform route to achieve the type of diversity that is observed in natural streams. The straightest section of the planned stream is downstream of the confluence with the North Fork of the Swan River. This section of the stream is proposed to remain in its current alignment. While straighter than a typical Type Cb stream this section of the stream was found to be functioning well with stable banks and established riparian vegetation along the stream corridor. Another section from approximately station 120+00 to 129+00 on the Preliminary Design Plan has been designed straighter than a typical Type Cb stream in order to maximize available usable land at the request of the current landowner. The exact sinuosity may evolve

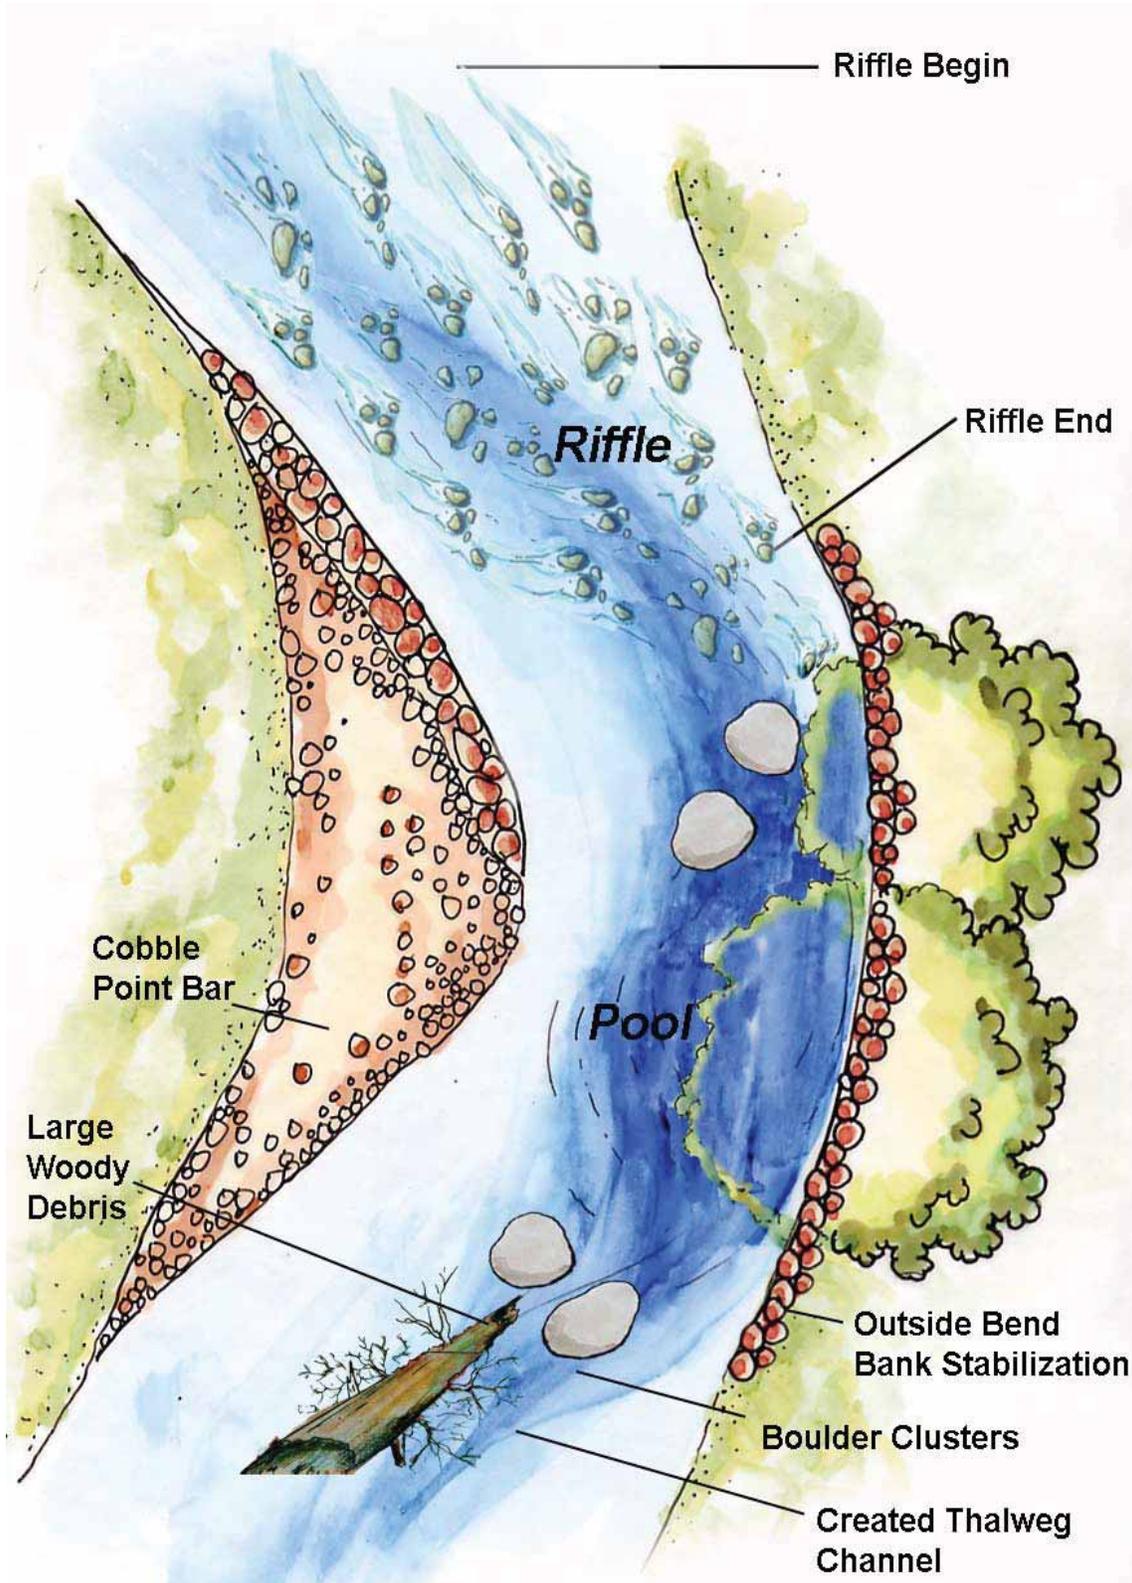
Figure 6.2. Schematic of Riffle/Pool Complex.

Type Cb streams are dominated by repeating riffle/bend pool complexes and point bars, as shown in **Figure 6.2**. Riffles are the steeper sections of the stream and generally located upstream from larger channel bends. Riffles are characterized by larger substrate material and swift flows. Pools are located downstream of riffles and are typically at or near the more pronounced bends in the stream. The higher flow velocity of the riffle sections provide energy required to continually scour the pools maintaining quality pool habitat. Glides are located between pools and riffles and generally have a mild adverse slope leading from the end of a pool up to the start of the next riffle. Glides have a well-defined thalweg that contain flow to a defined channel during low flow periods. Schematic templates depicting typical geometries of riffle, pool and glide cross sections are presented on **Sheet 9** of the Preliminary Design Plan.

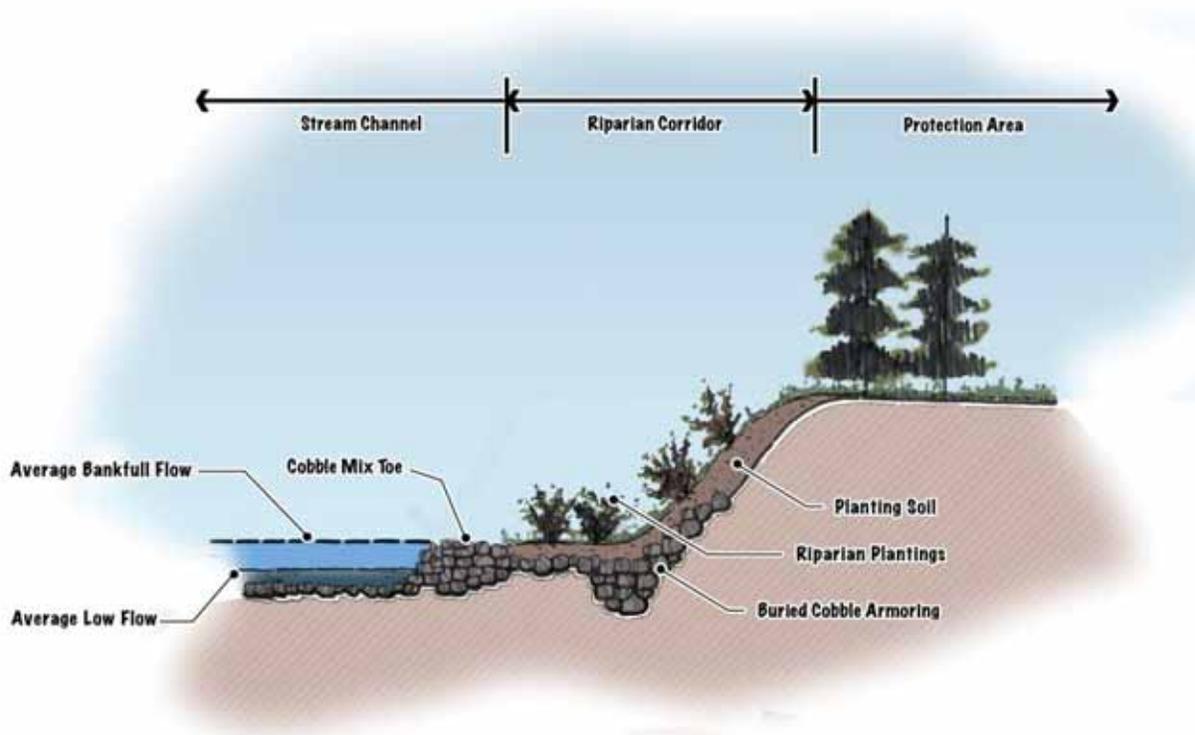
Figure 6.3. Schematic of Bank Armoring.

Specific locations may be defined where lateral channel migration should not be allowed. In critical locations the bank can be armored below the surface yet restored to resemble a natural channel. An example of a more structured bank armoring approach that can be utilized if needed is provided on **Figure 6.3**.

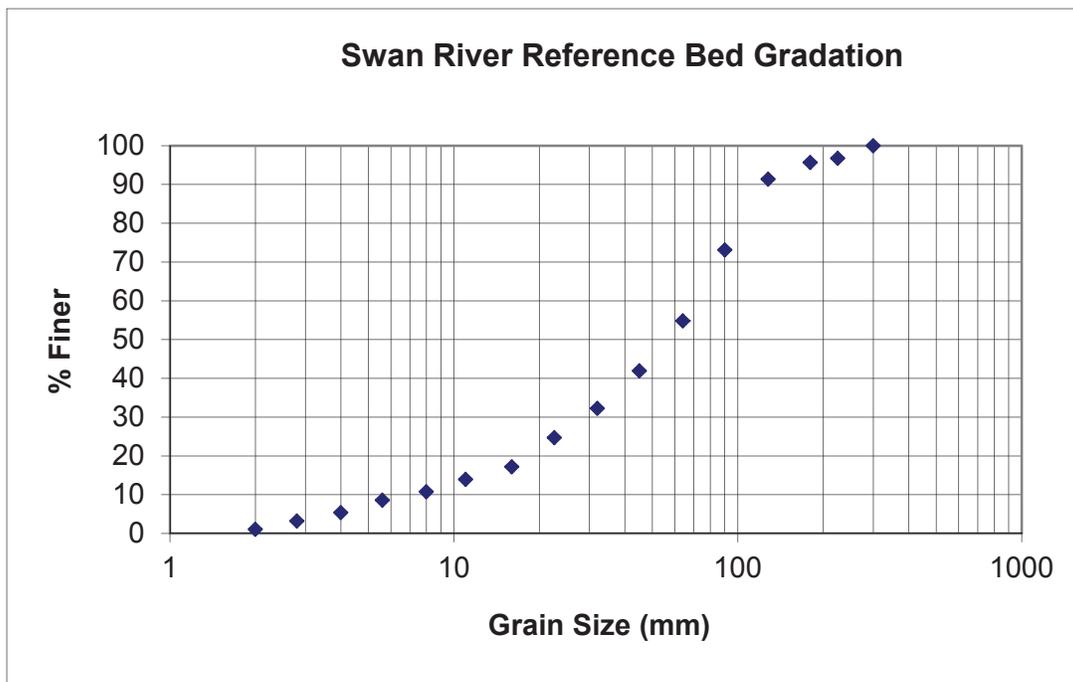
Figure 6.5. Reference Stream Bed Gradation.

This material specification was compared with an existing gradation measured by ERC in the stream reach downstream from the Project Area. Results of ERC's stream gradation analysis are shown on Figure 6.5.

Based on ERC's sampling, the D_{50} of the existing bed material is on the order of 55 mm (2.2 inches). Observations indicated some level of armoring. Following the method of Fuller and Thompson (1907), suggest that soils should have a fines content of between 5% and 15% based on the recommended range of n values in the procedure. Considering that the bed gradation measured by ERC likely overestimates the D_{50} due to armoring, the recommended fines content would be greater than the 5% - 15% range from the Fuller-Thompson method presented above. Use of 20% fines in the low permeability material is therefore believed to be appropriate.

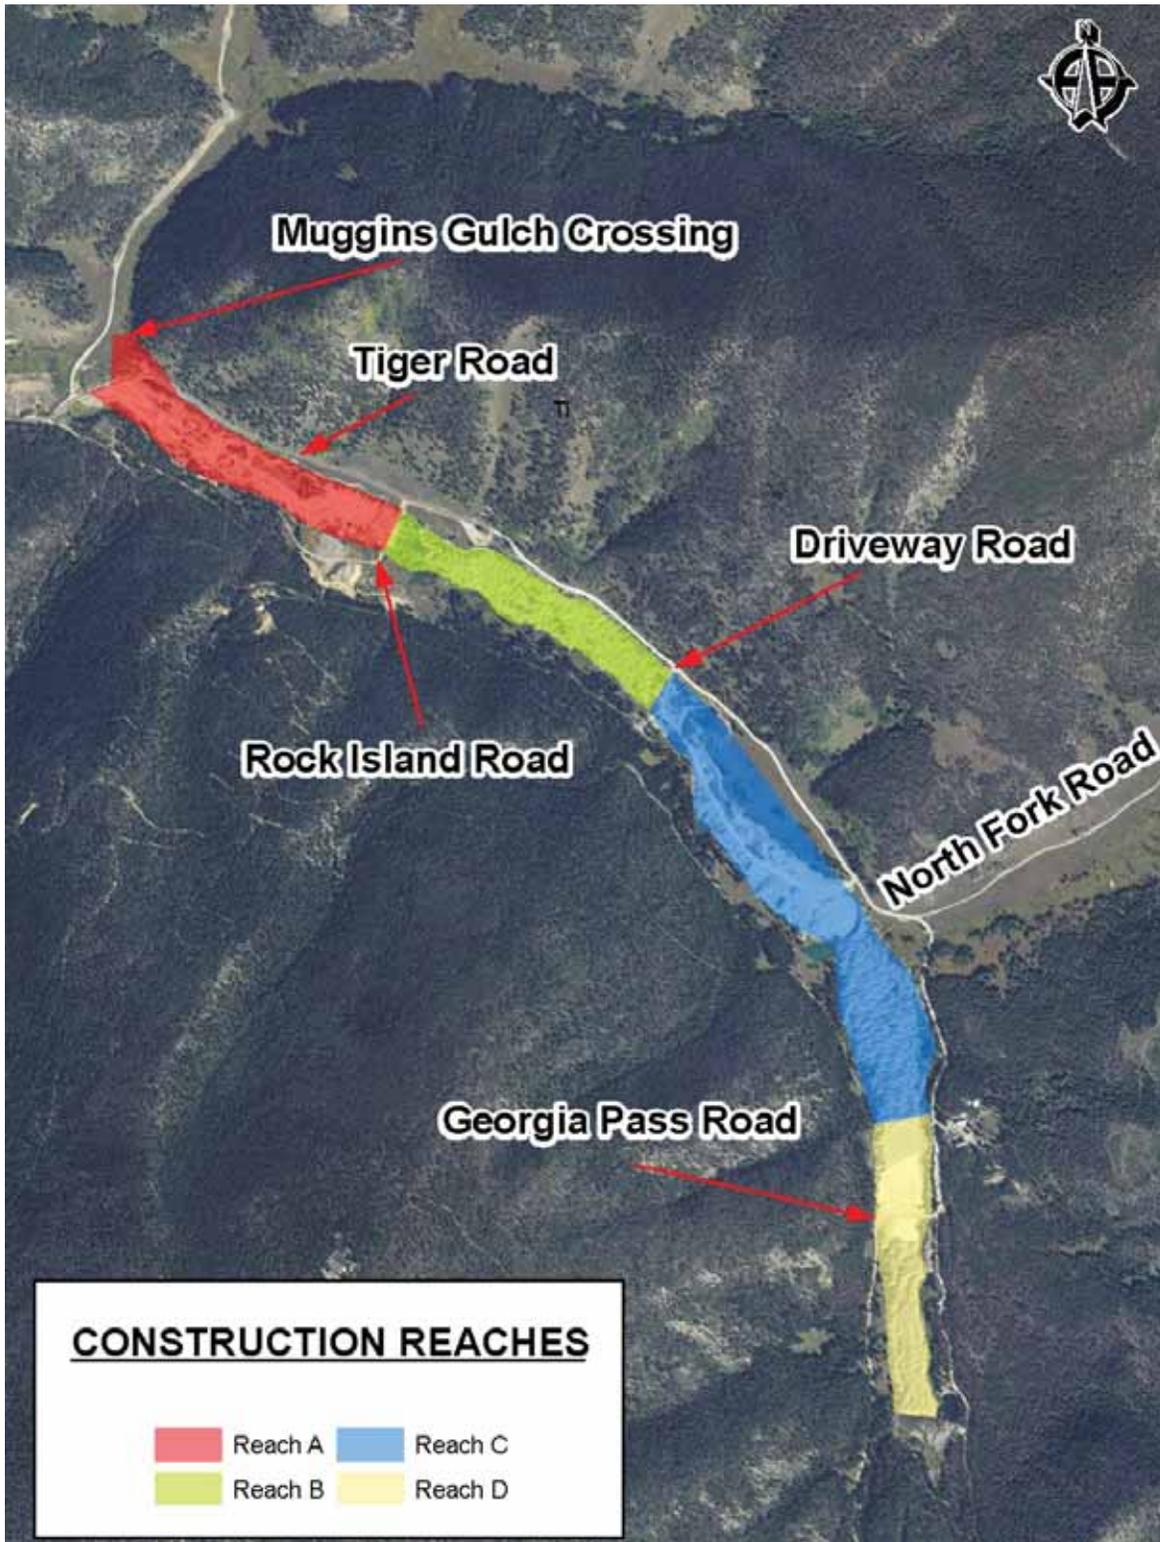
Figure 7.1. Approximate Locations of Recommended Construction Reaches

logical break point based on current dredge material removal. As discussed earlier, constructing different reaches at different times creates a project constraint in that it dictates that the elevation of the upstream and downstream end of each reach must generally match existing conditions in order to avoid a vertical disconnect during construction. The benefit of matching existing grade, however, is that the reaches can be designed to occur in any order. For this report reaches were identified as A through D starting at the downstream end of the project. Different reaches can be implemented in different order desired as financing is available and different lands are ready to be reclaimed. Table 7.1 shows the approximate stationing and road crossings included when defining each phase. A map of the approximate phase locations is shown in Figure 7.1.

Reach	Approximate Stationing	Included Road Crossing
A	0+00 to 32+50	Tiger Rd Muggins Gulch
B	32+50 to 67+50	Rock Island Rd
C	67+50 to 120+00	Driveway Rd
D	120+00 to 150+55	Georgia Pass Rd

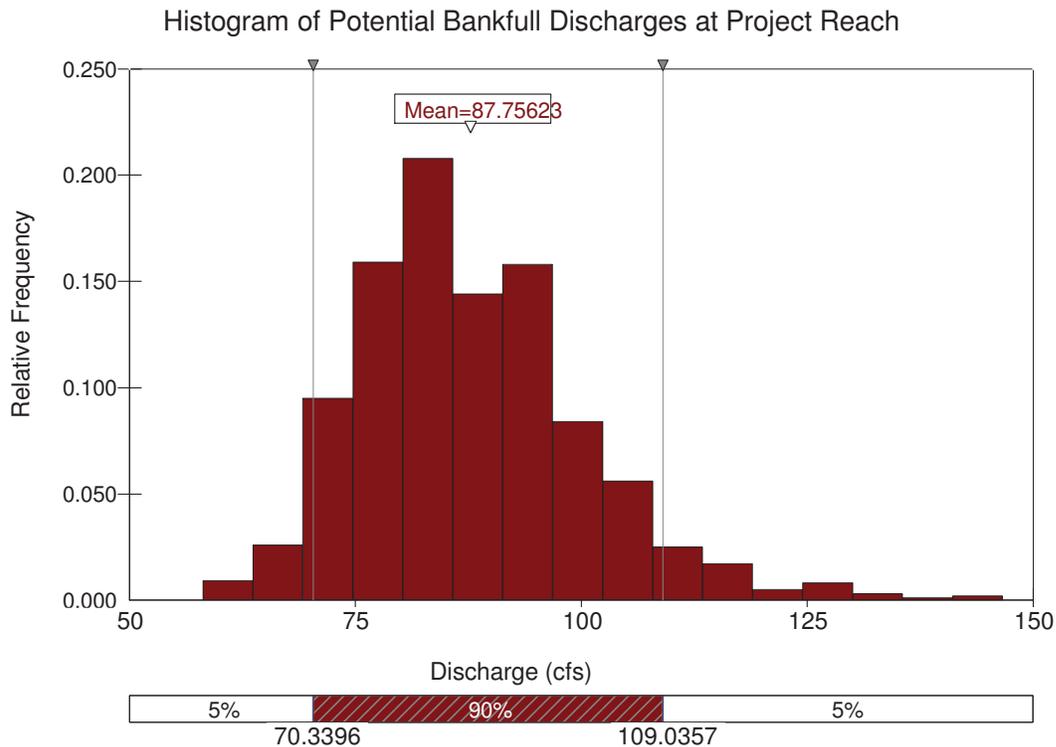
The Monte Carlo simulation was performed with an EXCEL add-on called @Risk. The bankfull discharge was repeatedly calculated with Manning’s equation by sampling from the previously described probability distributions. The summary results for 1000 iterations are shown below in Figure 1 and Table 1. The median value at the bottom end of the project reach is approximately 86 cfs, as previously calculated. However, a 90 percent confidence interval could be interpreted as 70.3 to 109.0 cfs. The interquartile range (25th to 75th percentile) could range from 79.1 to 94.8 cfs.

Figure 1. Histogram of 1000 iterations of Manning’s equation, generated by sampling from probability distributions for slope and roughness.

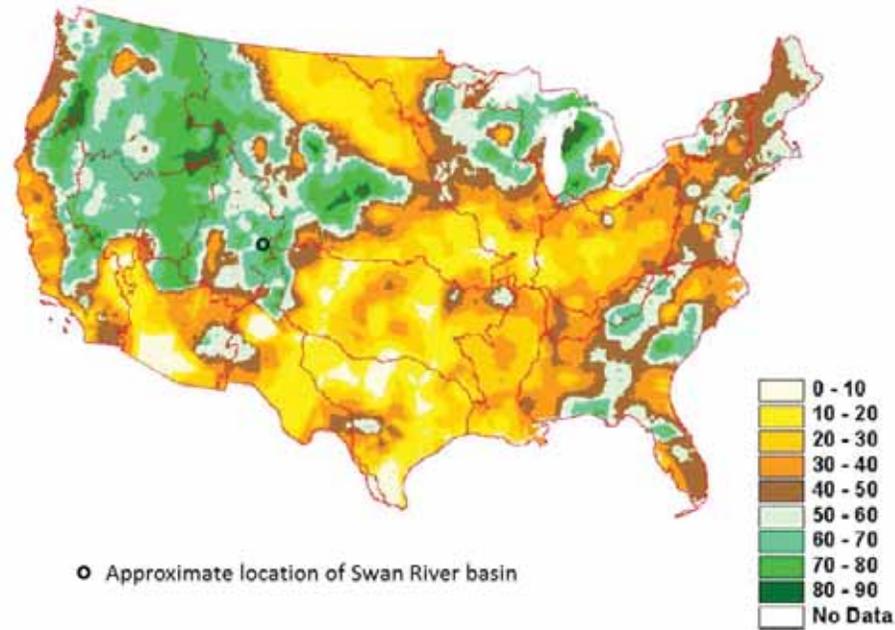
Figure 1: USGS Base Flow Index Map

Figure 1 shows a BFI map created by the USGS from a 1-km raster dataset (Wolock). Base flow index is defined as the percentage of total streamflow that can be attributed to ground water discharge, or base flow. The BFI is calculated by dividing base flow by total flow. The map in Figure 1 was developed by interpolating BFI values obtained using a smoothed minima technique to separate base flow from total flow for 8,249 streamflow records. These records spanned an average of 33 years of daily observations. The average observed basin size was 528 km². Using the map in Figure 1, the BFI in the Swan River watershed can be approximated as 60-70%.
