SWAN RIVER RESTORATION PRELIMINARY DESIGN PLAN REPORT

March 22, 2013

ERC Project # 860-1201

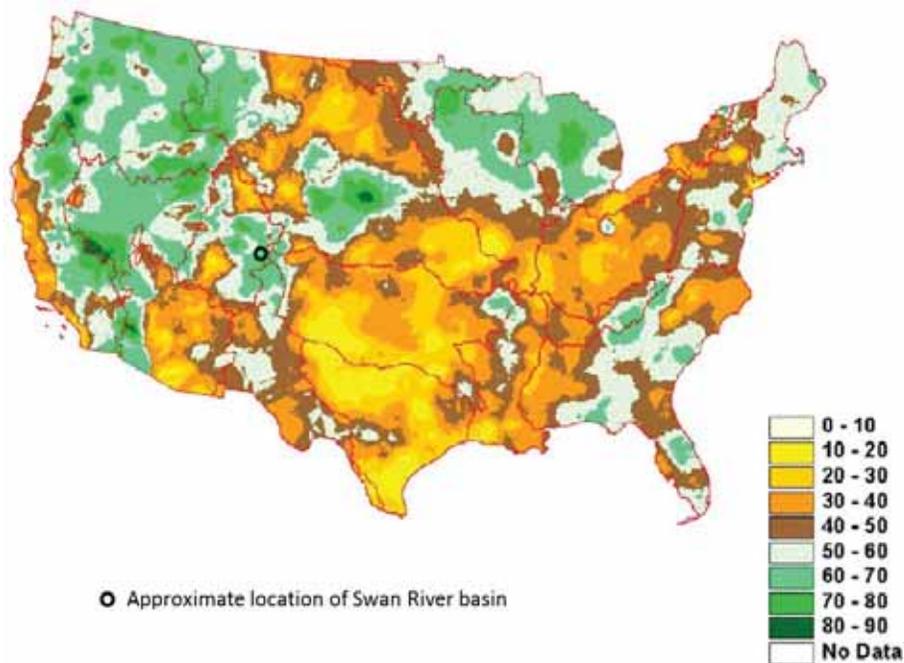
Figure 2: Santhi, et al (2008), Base Flow Index Map

Figure 2 shows a BFI map created by Santhi, *et al.* (2008). This map was developed by interpolating BFI values using a digital filtering technique to separate base flow from total flow for nearly 8,600 streamflow records. These gauges were selected from basins of drainage areas of 50-1,000 km² and consisted of at least 10 years of daily records from low ET months. Using the map in Figure 2, the BFI in the Swan River watershed can be approximated as 60-70%.
